Program Bulletin

CUSTOMER SATISFACTION PROGRAM

SUBJECT: Engine Block Coolant Heater Seal Leaking / Power Cord Melted

MODELS: 2003-2015 Chevrolet Express 3500 / 4500
2003-2007 Chevrolet Silverado 3500
2008-2013 Chevrolet Silverado HD
2003-2015 GMC Savana 3500 / 4500
2003-2007 GMC Sierra 3500
2007-2012 GMC Sierra HD
Equipped with Duramax Diesel Engine RPO YF2 and Coolant Heater K05

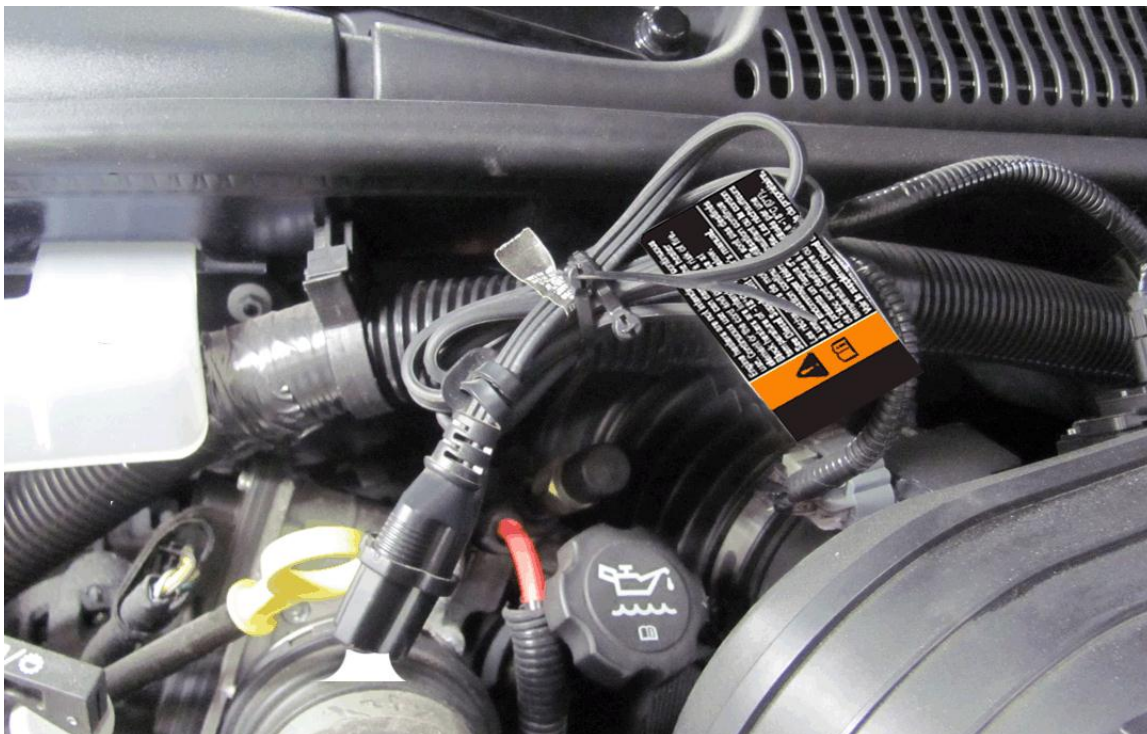
4211949

- Attach the “Not for Continuous Use – See Owner Manual” warning label to the OEM coolant heater power cord. Attach the label 254 mm (10 in) from the end of the cord. Refer to the photograph.

Note: If the coolant heater power cord is replaced, the new cord may have the warning label attached to it. If the new cord does not have the label attached to it, attach the warning label to the power cord.

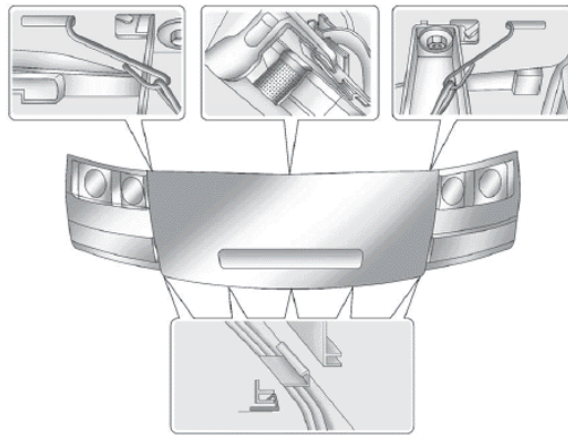
- 2. Hook the five J-clips to the bottom edge of the grille.
- 3. Hook the top center J-clip by the hood latch.

- 4. Attach the metal hooks, one each at the top corners.
- 5. To remove the winter cover, reverse the steps listed previously.
