04380 Version 1

Buttons Sticking on Audio-Navigation Unit (Day/Night, Settings, Navi or Audio)

AFFECTED VEHICLES

Year	Model	Trim	VIN range
2015–16	TLX	ALL	ALL

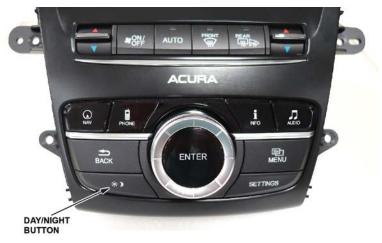
1. Check and note which buttons are sticking. (NAV, AUDIO, Day/Night and SETTINGS)

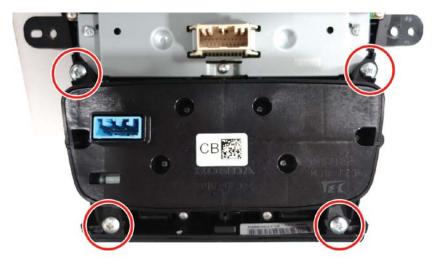
- 2. Remove the audio-navigation unit. Refer to service information.
- 3. Get a clean, large, dense foam pad or a clean, soft cotton towel to lay the unit on. Do not use shop rags; they may contain metal particles.
- 4. Loosen the screws shown below one full turn using a hand-held screwdriver.

NOTE: Do not use an electric or pneumatic screwdriver; these screws can be easily stripped and damage the audio-navigation unit.

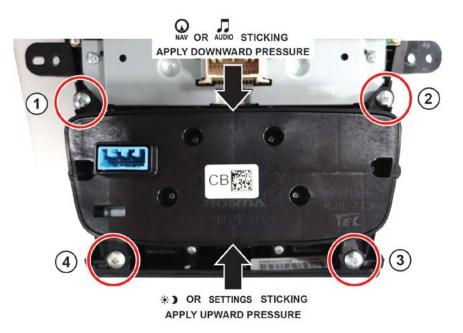
- 5. Adjust the audio-navigation unit as follows:
 - AUDIO or NAV buttons: Apply downward pressure.
 - Day/Night or SETTINGS buttons: Apply upward pressure.

6. While applying upward or downward pressure, tighten the screw behind the sticking button first, then tighten the other three screws while continuing to apply pressure.

Example: If the AUDIO button is sticking, you would tighten the screws in the order pictured above.
