TSB140019
-----------

## Technical Service Bulletin

Fuel Pump - Plunger and Tappet Roller Inspection and Repair

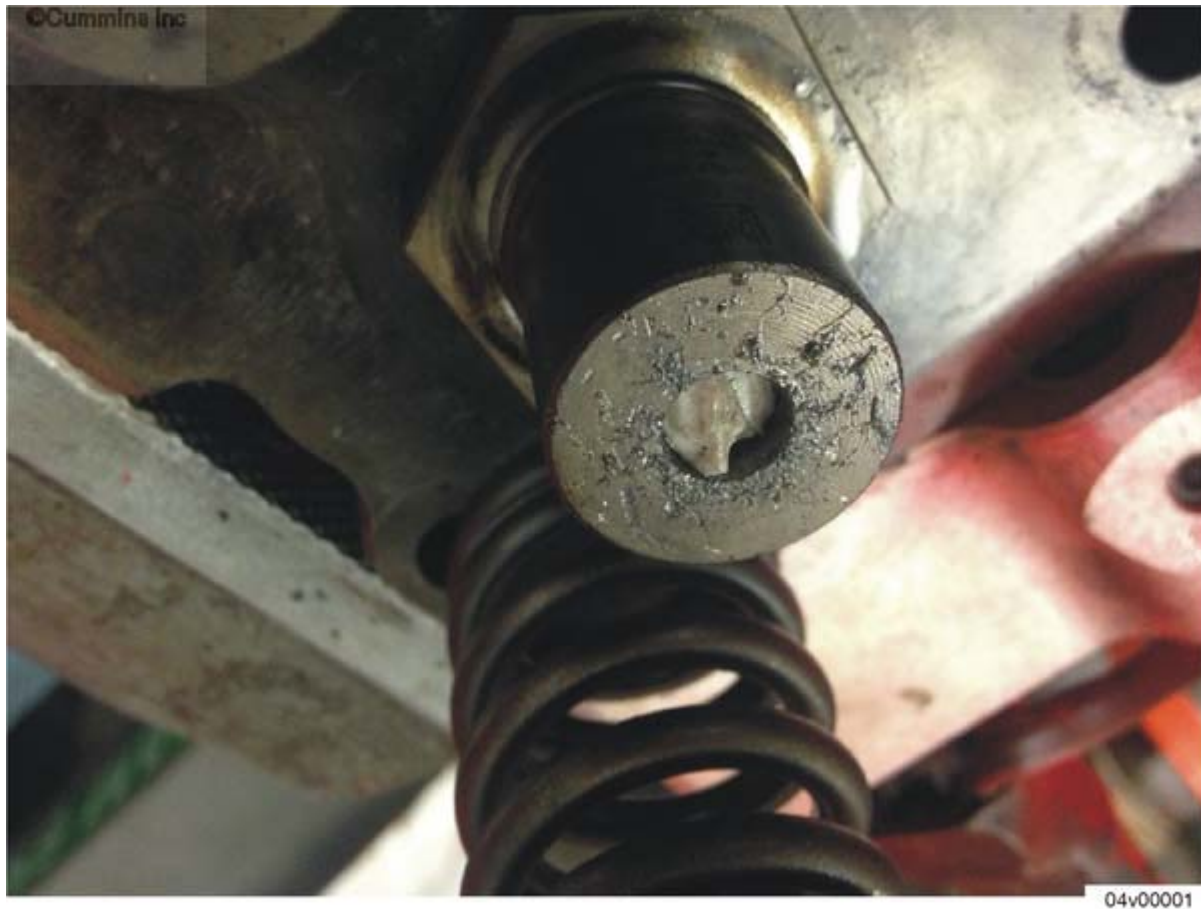
Figure 1, Fractured Fuel Pump Ceramic Pumping Plunger.

This document, in conjunction with the information provided within the manuals listed in Table 1 provides inspection and repair guidelines following the malfunction of a fuel pump pumping plunger and/or roller tappet assembly.

Previous versions of this document provided specific repair directions according to the vintage of the fuel pump and type of pumping plungers. Repair directions have now been made common and apply to all fuel pumps regardless of vintage, pumping plunger type, or tappet roller assembly type.

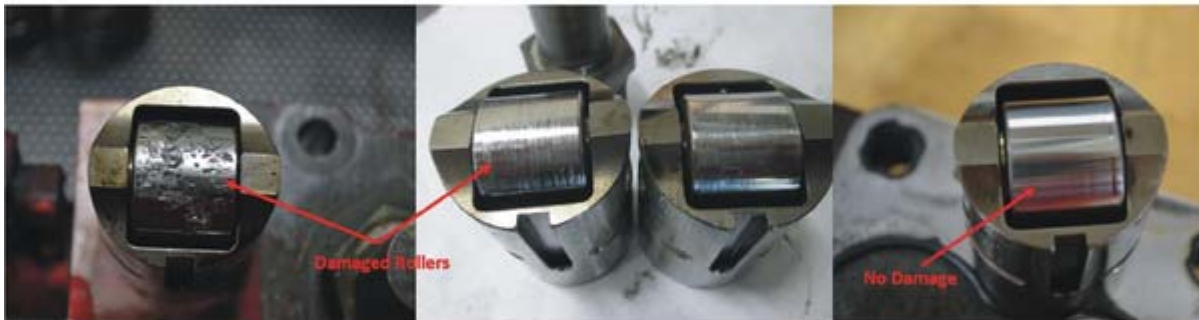
04v00002

Figure 2, Fuel Pump Tappet Roller Assemblies.

Inspect and verify the condition of the fuel pump tappet rollers. Reference Figure 2 above and Procedure 005-227 in Table 3 below.

Scenario 1: The fuel pump tappet rollers are damaged:

- Remove, cut open, and inspect the lubricating oil filter for debris. See Procedure 007-083 in Table 3.
- Connect INSITE™ electronic service tool to the service tool data link and review any logged fault codes.
- Reference Table 1 below for repair direction.

Scenario 2: The fuel pump tappet rollers are **not** damaged:

- Connect INSITE™ electronic service tool to the service tool data link and review any logged fault codes.
- Reference Table 1 below for repair direction.
