Technical Bulletin

26 16 03 June 20, 2016 **2039436** Supersedes Technical Bulletin V261602 dated March 31, 2016 to update labor operations according to Saga/Elsa update 6/13/16.

AdBlue® Warning and or MIL ON – AdBlue® Leakage at Reductant Injector

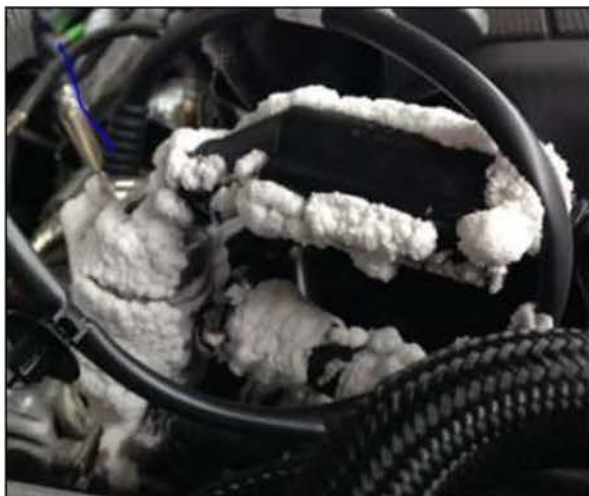
Welding process issues of the reductant line connector to the supply line may cause AdBlue® leakage at the reductant injector.

Inspect the connection of the reductant supply line connector at the reductant injector in the engine compartment. If white crystalized (dried) AdBlue® is found at the reductant injector (see Figure 1 & 2), it will be necessary to replace the reductant supply line.

Thoroughly clean the area of the reductant supply line connection with water to remove the crystalized AdBlue®. Replace the reductant supply line.

It is not necessary to replace the reductant injector.
