TSB140159

ISX15 / QSX15 CM2250 and ISX12 / QSX12 CM2250 Engines have Fault Codes 1139, 1141, 1142, 1143, 1144, or 1145 caused by Fuel Pump Inlet Banjo Sealing Washer Debris

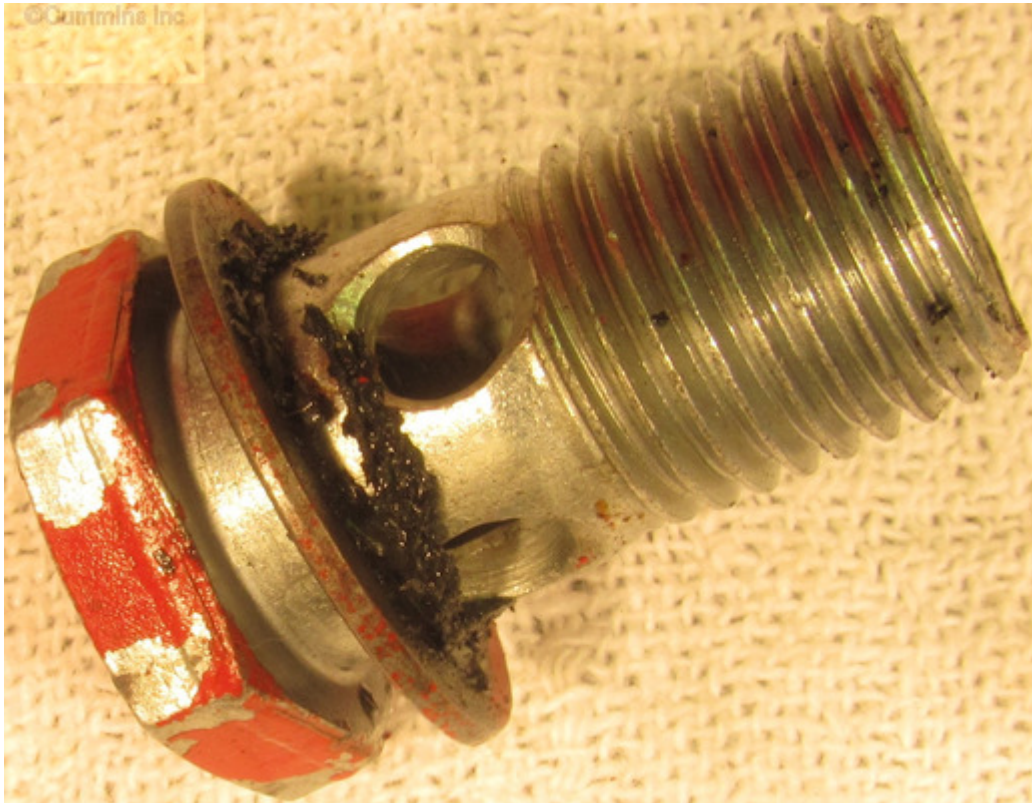
05r00019

Engines have returned after previous repair with injector fault codes 1139, 1141, 1142, 1143, 1144, or 1145. The root cause of these fault codes is debris from the fuel pump inlet banjo sealing washer, Part Number 3963988 or 3963991, blocking the fuel returned from the fuel pump head. The most common occurrences have been noted with the following campaigns.

Figure 1, Fuel Pump Inlet Banjo Sealing Washer Debris

When opening the fuel system, clean and inspect all components thoroughly. When removing the fuel supply line from the fuel filter outlet and the high-pressure fuel pump, discard the sealing washers as indicated in the service procedure. Before reinstalling the fuel supply line to the fuel filter outlet and the high-pressure fuel pump, clean the fuel supply line banjo fitting with contact cleaner to flush any debris that may have accumulated. Replace the fuel pump inlet banjo sealing washers and install the fuel supply line. See Procedure 006-024 in Section 6 of the appropriate service manual.
