GROUP ENG	MODEL 2016MY Optima (JF/JFa) Sorento (UMa) 2017MY Sportage (QL)
	NUMBER 159	DATE September 2016

TECHNICAL SERVICE BULLETIN

SUBJECT: E-CVVT COVER AND MOTOR PLUG REPLACEMENT

This bulletin provides information about the replacement of the E-CVVT cover and motor plug on some 2016MY Sorento (UMa), produced from October 27, 2014 to June 14, 2016, 2016MY Optima (JF/JFa), produced from August 29, 2015 to June 14, 2016, and 2017MY Sportage (QL) vehicles, produced from December 10, 2015 to June 15, 2016, which may exhibit a MIL ON with DTC P001000 and/or oil leakage in the E-CVVT motor plug of applicable vehicle models equipped with 2.4L GDI or 2.0 T-GDI engines. Follow the procedure outlined in this bulletin to replace the E-CVVT cover and motor plug to correct the concern.

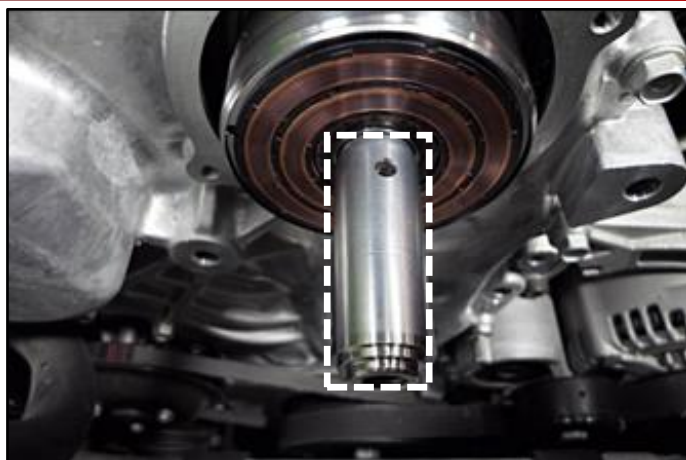
- Apply oil to the oil seal lip of the new E-CVVT cover and install the SST "B" to the E-CVVT motor as shown.

When installing the cover, correctly insert the end of the SST to the motor shaft as shown below. Ensure that the SST hole faces towards the motor shaft.

SST INSERTED INCORRECTLY

SST INSERTED CORRECTLY

E-CVVT removed from vehicle for demonstration only purposes.
