TSB140019
-----------

Fuel Pump - Plunger and Tappet Roller Inspection and Repair

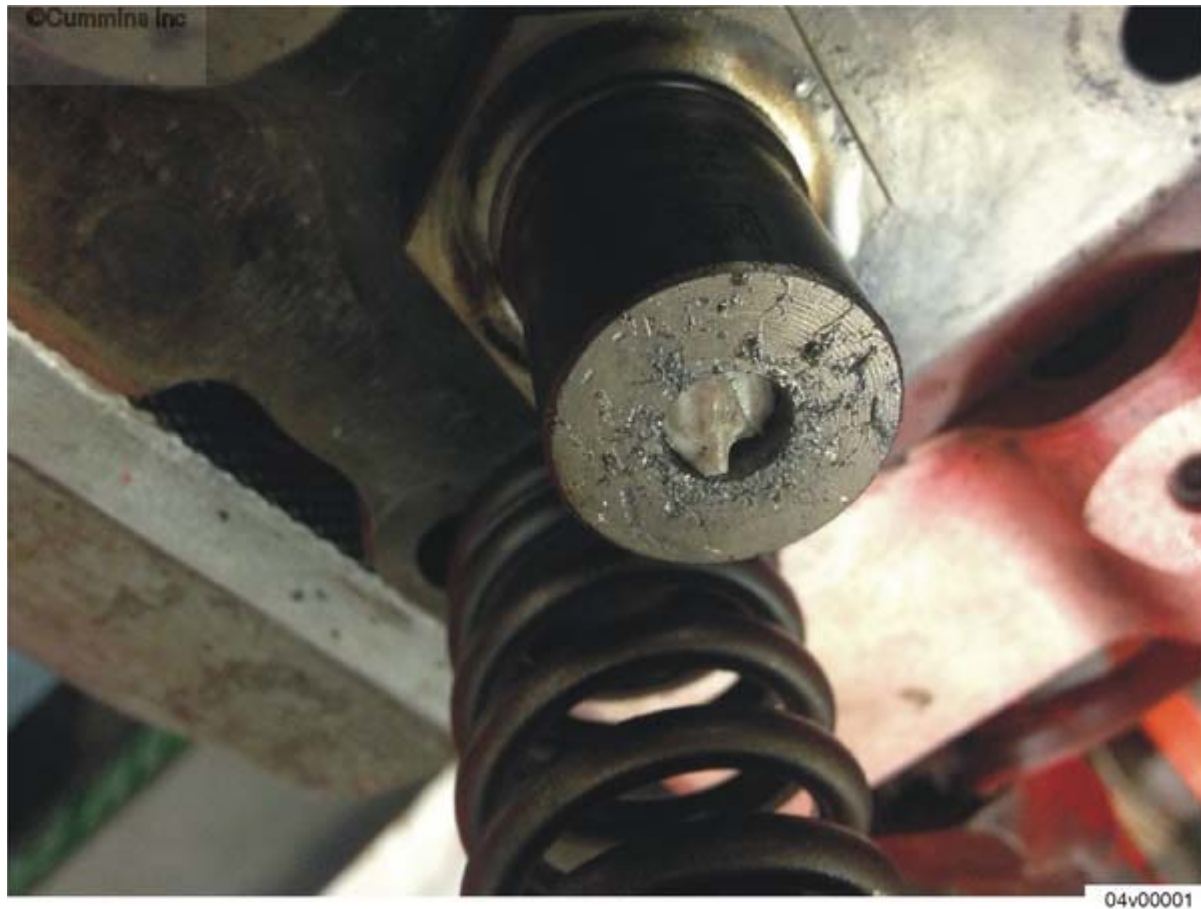
Figure 1, Fractured Fuel Pump Ceramic Pumping Plunger.

This document, in conjunction with the information provided within the manuals listed in Table 1 provides inspection and repair guidelines following the malfunction of a fuel pump pumping plunger and/or roller tappet assembly.

The level of progressive damage to the fuel pump and other engine components will vary with every incident; however, the repair direction will depend on **only** a few key criteria.

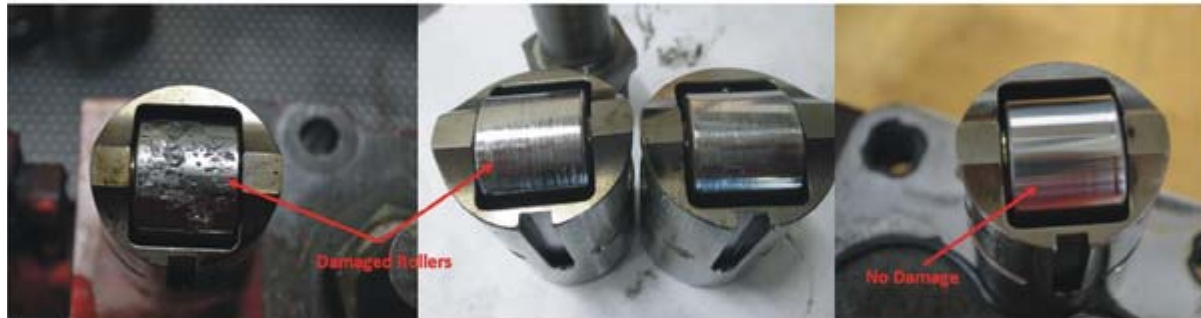
04v00002

Figure 2, Fuel Pump Tappet Roller Assemblies.

Inspect and verify the condition of the fuel pump tappet rollers. Reference Figure 2 above and Procedure 005-227 in Table 3 below.

Scenario 1: The fuel pump tappet rollers are damaged:

- Remove, cut open, and inspect the lubricating oil filter for debris. See Procedure 007-083 in Table 3.
- Connect INSITE™ electronic service tool to the service tool data link and review any logged fault codes.
- Reference Table 1 below for repair direction.

Scenario 2: The fuel pump tappet rollers are **not** damaged:

- Connect INSITE™ electronic service tool to the service tool data link and review any logged fault codes.
- Reference Table 1 below for repair direction.
