Technical Service Bulletin

70 Rattle noise in left front dash from head-up display

70 16 54 2044763/2 July 19, 2016. Supersedes Technical Service Bulletin Group 70 number 16-53 dated July 7, 2016 for reasons listed below.

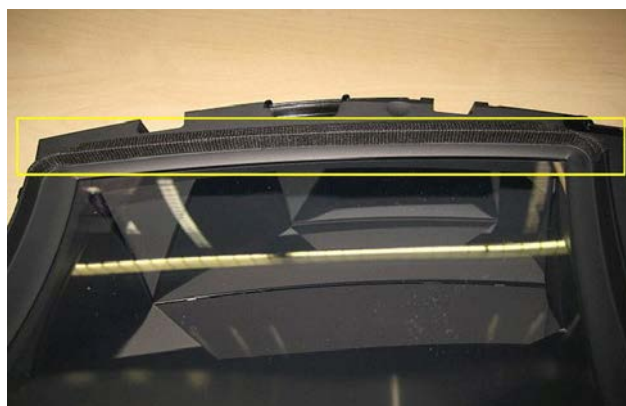
When the vehicle is driven over poor road surfaces, creaking or rattling noises can be heard from the upper dash panel on the driver's side.

The upper and lower head-up display trim pieces are making contact, which causes the noise.

Figure 1. Placement of textile tape.

Cover the trim of the head-up display with textile tape (part number D 373125A2), as shown (Figure 1). Ensure that the tape completely covers the edge of the trim.
