TECHNICAL BULLETIN
JTB00339NAS1
04 FEB 2014

SECTION: 501-14

'Hood Open' Message Displayed on Instrument Cluster

XJ Range (X351)

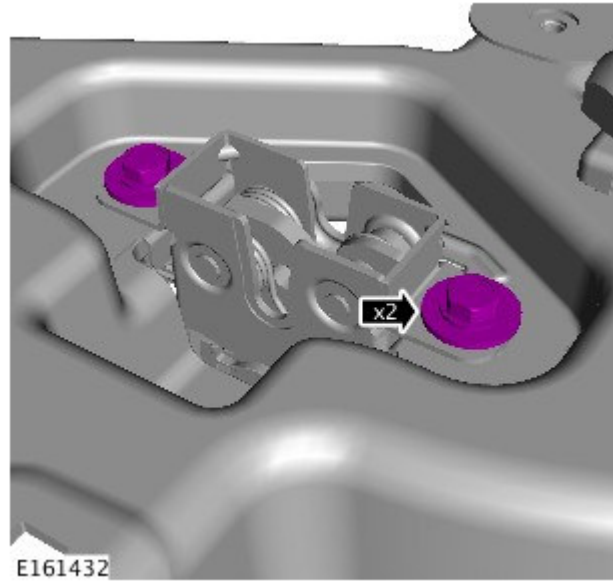
1. Open the hood.
2. Remove the two bolts from the left-side hood latch.

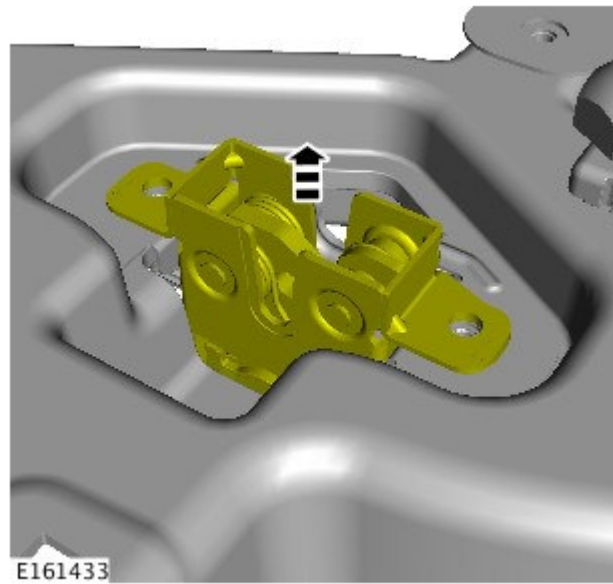
- 3. Lift the left-side hood latch upwards to allow access to the spacer.

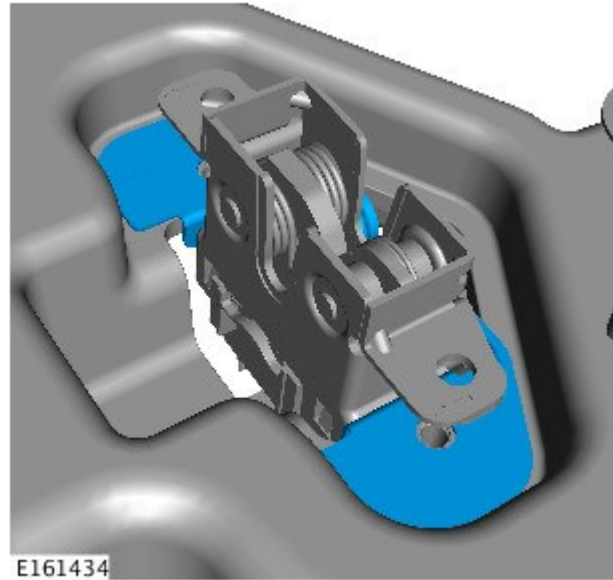
- 4. Remove the spacer.

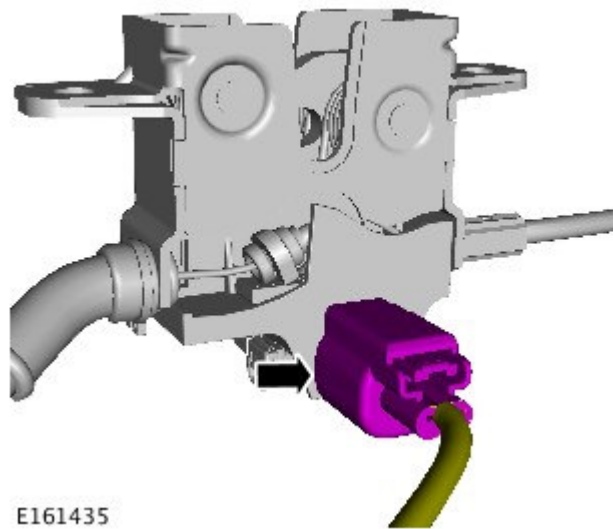
5. Disconnect the electrical connector.

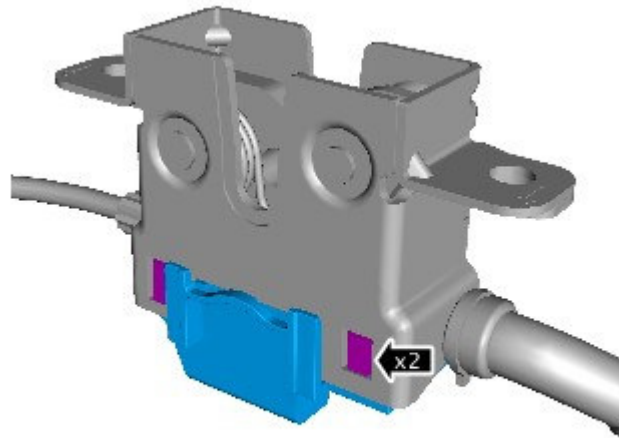
E161436

6. Remove the switch:

- Release the two clips.

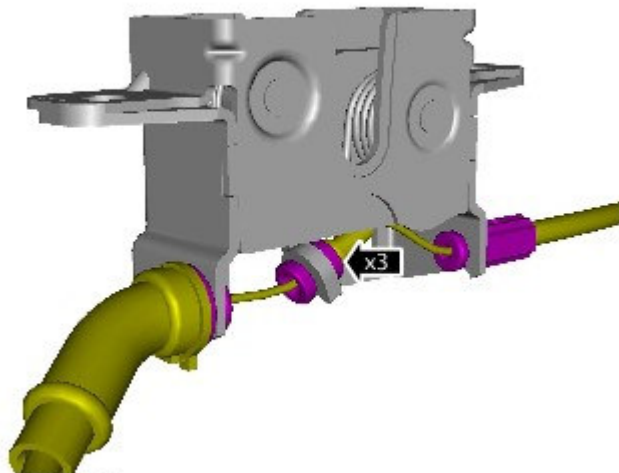
E161437

7. Release the hood cable.
