October 1, 2015

02517 Version 1

Safety Recall: Front Passenger's Airbag Inflator Can Be Over-Pressurized

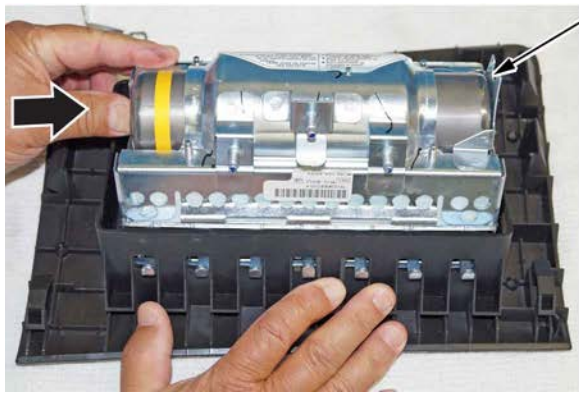
- Slide the inflator in until the “D” aligns with the tab on the inflator bracket. There should be no space or gap between the inflator and bracket.

No gap.

TAB ON BRACKET

“D” SHAPED END

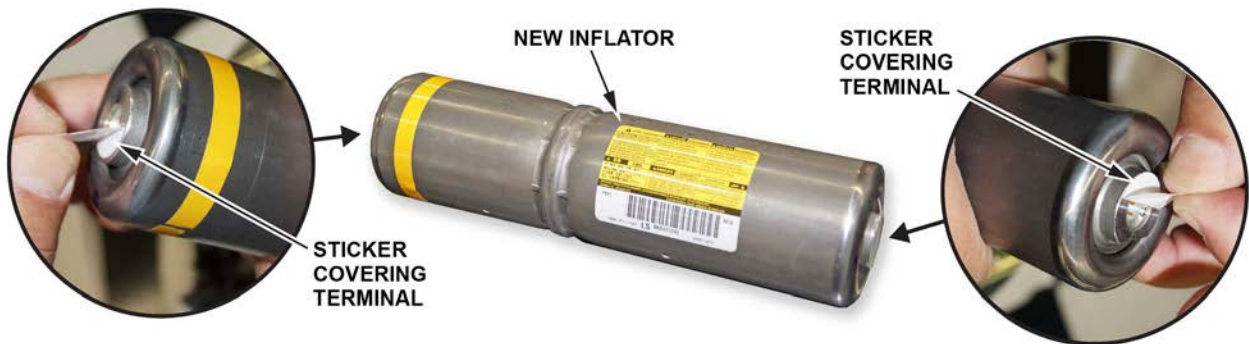
15. Remove the stickers covering the terminals on both sides of the new inflator.
