51869-02162 Version 5

Warranty Extension: MIL Comes On with DTCs P0301 thru P0304

Year	Model	Trim	VIN Range
2008–12	Accord	All V6 A/T	Check the iN VIN Status for Eligibility.

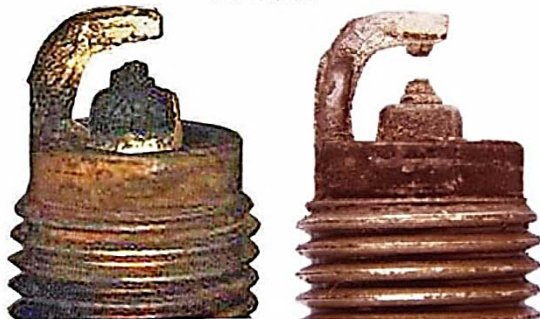
2. Remove and check the spark plug(s) on the affected cylinders (example: if P0301 is stored, check the spark plug on cylinder No. 1).

Are the spark plug(s) fouled?

GOOD

NO GOOD

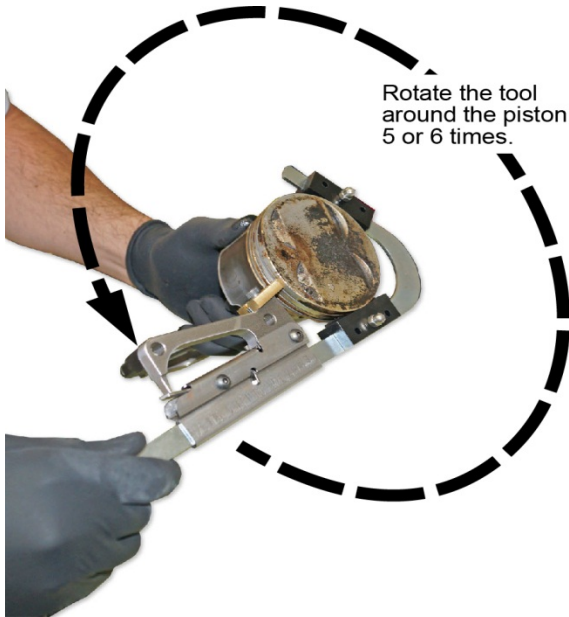
6. Hold the piston steady and rotate the tool counterclockwise five to six times to remove any carbon deposits in the piston ring grooves. **Do not** rotate the tool clockwise.

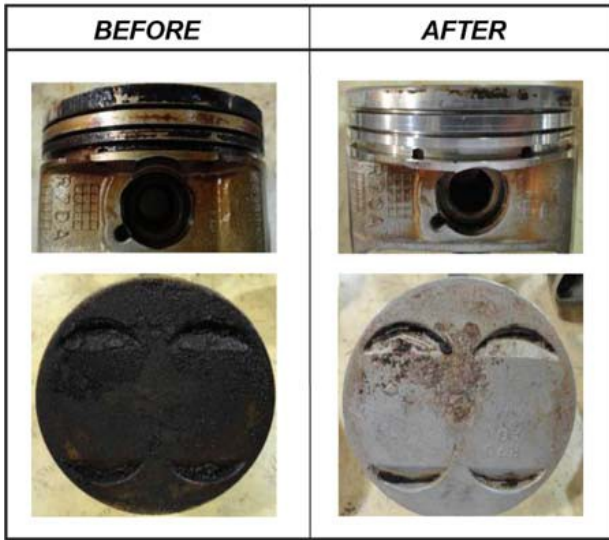
54K PISTON

NOTE: Below are some examples of before and after pictures. Depending on mileage and running conditions, the pistons will achieve different levels of cleanliness.
