02517 Version 3

Safety Recall: Front Passenger's Airbag Inflator Can Be Over-Pressurized

Replace the passenger's airbag inflator, then return the original, undeployed inflator as directed.

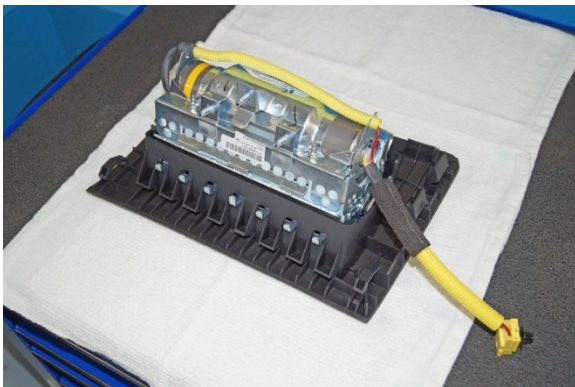
3. Remove the front passenger's airbag. Refer to the service repair information.
 4. Place the airbag, face-down, on a clean shop towel.

- The orientation of the airbag is critical because if the inflator is installed incorrectly, the harness will be too short when you reinstall the airbag.
- The brackets between the various models are similar but may differ from the example shown.

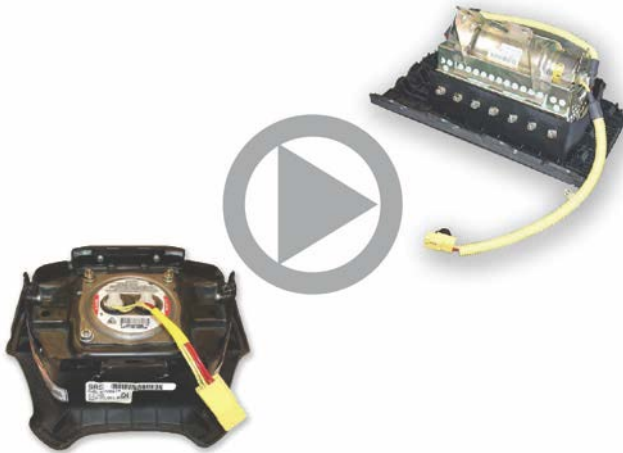
Click on the image below for a short video about the different variations of the driver's and front passenger's replacement inflators involved with the recalls related to inflators. While both the driver's and front passenger's inflators are shown in the video, this is informational only. Replace inflators only as directed by the iN VIN status inquiry.
