December 19, 2015

02517 Version 2

## Safety Recall: Front Passenger's Airbag Inflator Can Be Over-Pressurized

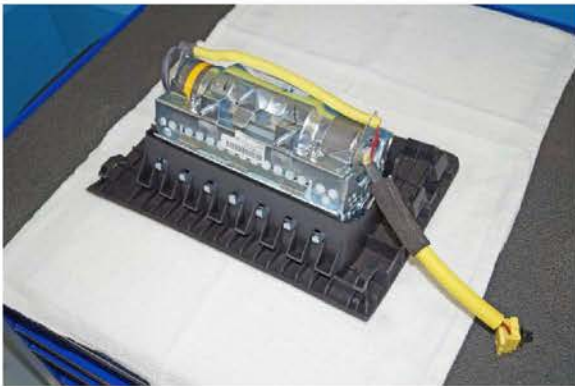
4. Place the airbag, face-down, on a clean shop towel.

- The orientation of the airbag is critical because if the inflator is installed incorrectly, the harness will be too short when you reinstall the airbag.
- The brackets between the various models are similar but may differ from the example shown.

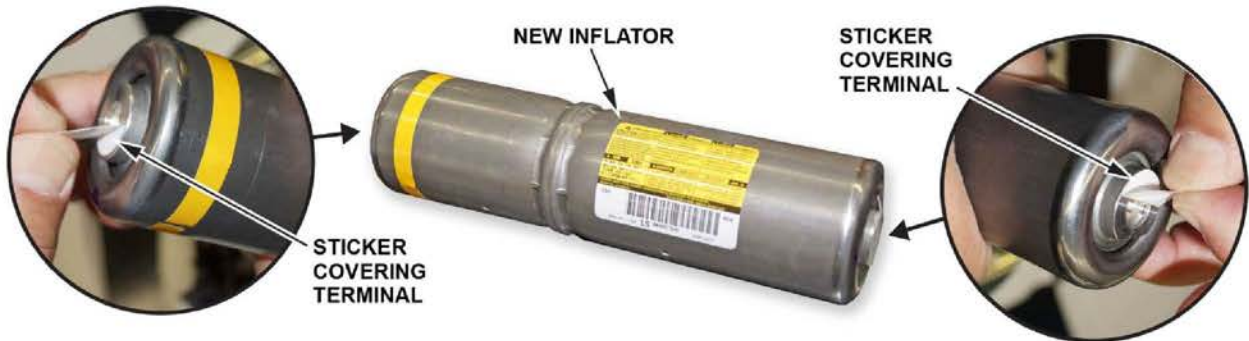
15. Remove the stickers covering the terminals on both sides of the new inflator.

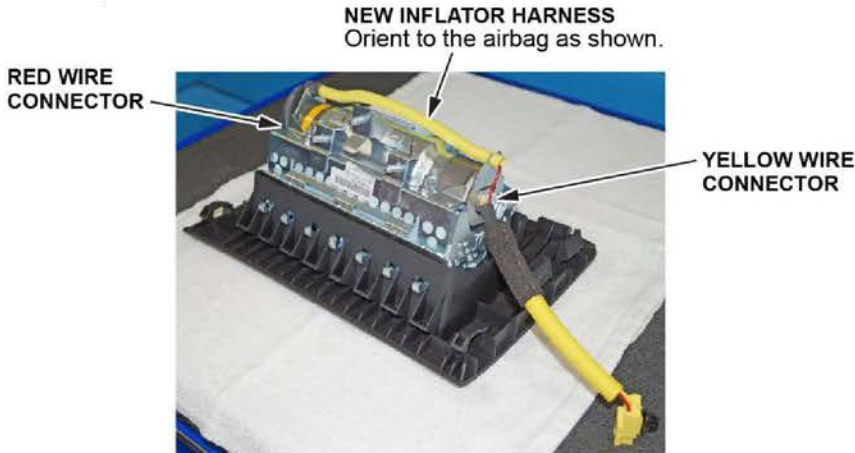
- Make sure the airbag and harness are aligned as shown.

- **Make sure you have the orientation correct as shown below.** If you connect the harness incorrectly, the harness cannot be removed, and you will not be able to reinstall the airbag because the harness will be too short.
- On the replacement inflators with plastic collars, connect the red wire connector to the connector with the red dot.
- On the replacement inflators without plastic collars, connect the red wire connector to the connector nearest the yellow band.
