50065-02166 Version 9

Warranty Extension: MIL Comes On With DTCs P0301 thru P0304

Year	Model	Trim	VIN Range
2011–13	Odyssey	ALL	Check the iN VIN Status for Eligibility

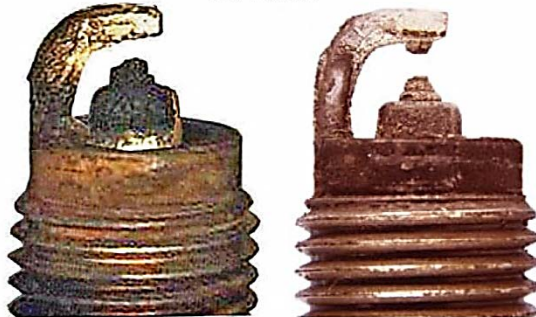
2. Remove and check the spark plug(s) on the affected cylinders (example: if P0301 is stored, check the spark plug on cylinder No. 1).

Are the spark plug(s) fouled?

GOOD

NO GOOD

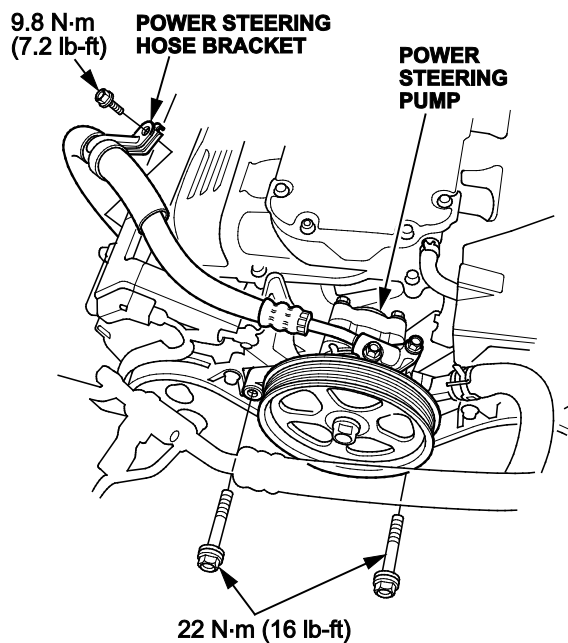
20. Remove the drive belt.
21. Remove the drive belt auto-tensioner.
22. Remove the power steering pump bolts, the power steering bracket then secure the power steering pump out of the way.

NOTE: Do not remove any of the hoses.

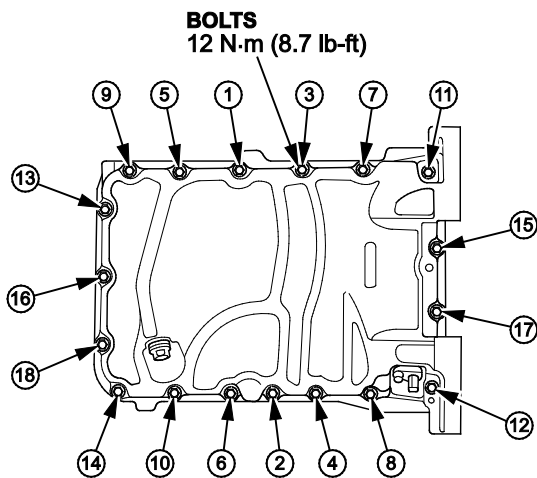
45. Remove all bolts securing the oil pan.

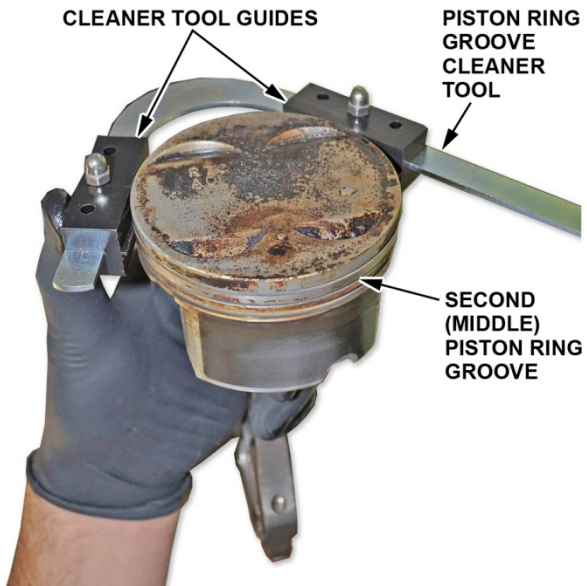
2. Spray the piston head and piston ring grooves thoroughly with Honda throttle plate cleaner.
3. While holding the piston upright in your left hand, take the piston ring groove cleaner tool in your right hand and line up the cleaner tool guides with the second (middle) piston ring groove.

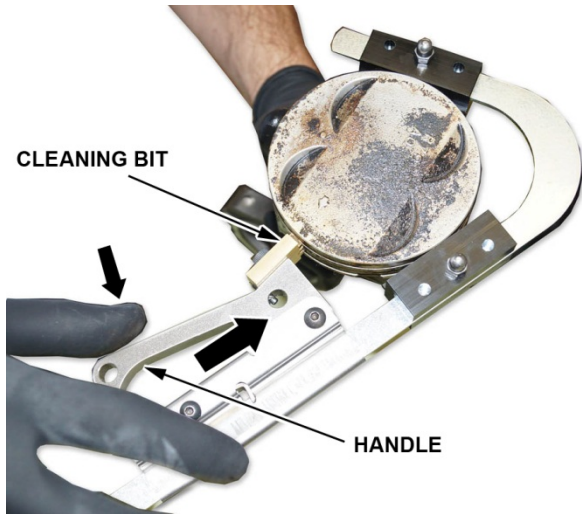
4. Press the handle on the piston ring groove cleaner tool and slide the cleaning bit onto the appropriate piston ring grooves.

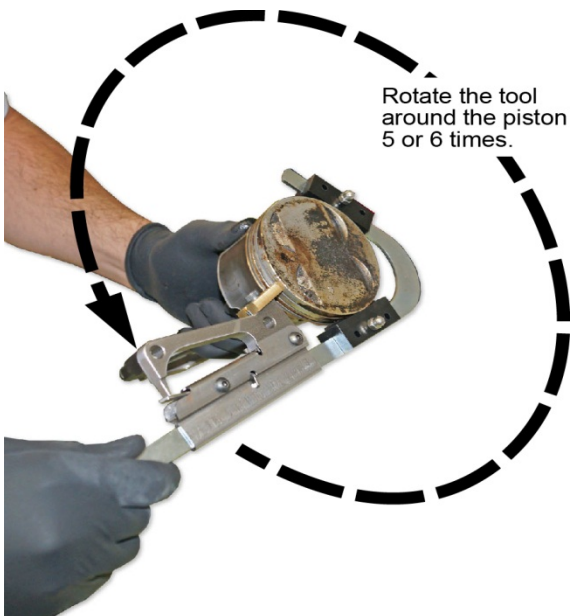
6. Hold the piston steady and rotate the tool counter-clockwise five to six times to remove any carbon deposits in the piston ring grooves. **Do not** rotate the tool clockwise.

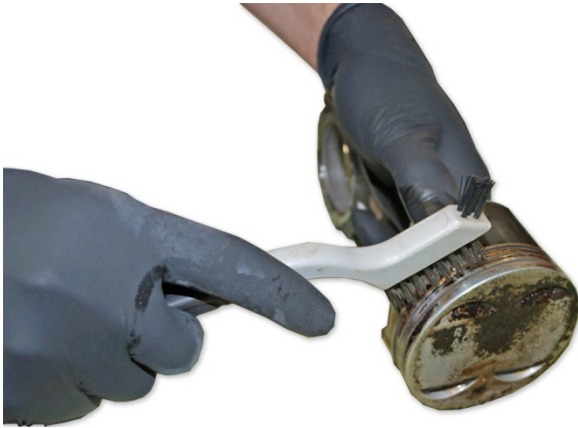
7. Remove the piston groove cleaning tool and clean off the carbon from the tool bit.
8. Finish cleaning the piston with throttle plate cleaner and the nylon brush. **Do not** use a steel wire brush.

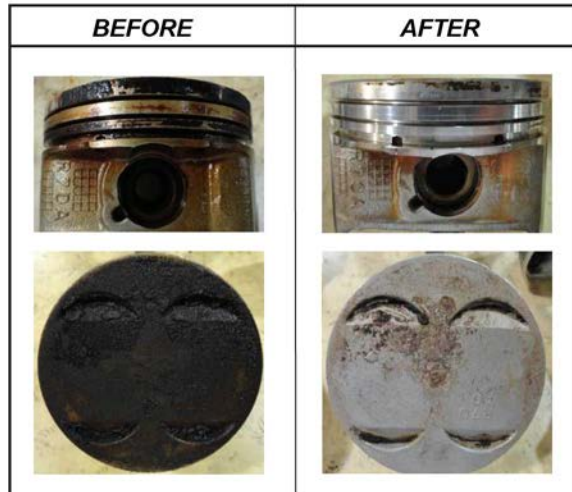
54K PISTON

NOTE: Below are some examples of before and after pictures. Depending on mileage and running conditions, the pistons will achieve different levels of cleanliness.
