September 16, 2015

51968-01885 Version 10

Recall: Front Passenger's Airbag Inflator May Produce Excessive Pressure After Long-Term Exposure To High Absolute Humidity

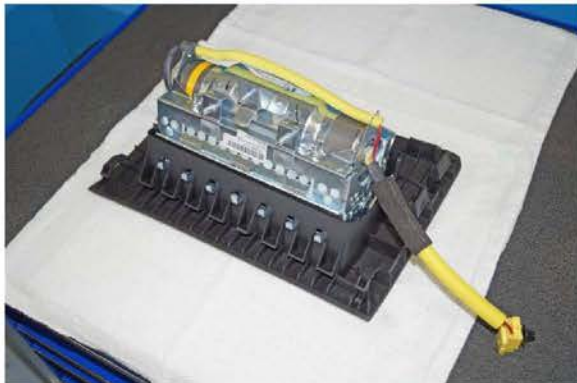
4. Place the airbag, face-down, on a clean shop towel.

- The orientation of the airbag is critical because if the inflator is installed incorrectly, the harness will be too short when you reinstall the airbag.
- The brackets between the various models are similar but may differ from the example shown.

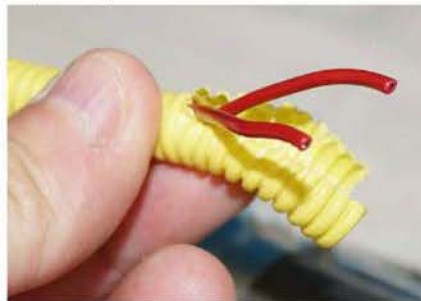
- Cut about 2 inches of the corrugated tube, then pull out the two red wires.

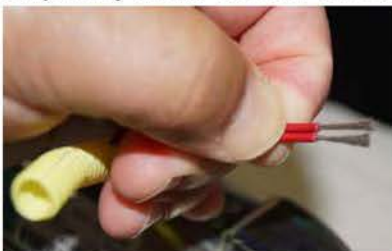
- Strip away about 1 inch of the wire insulation, then twist the wires together.

- Tape the twisted ends with electrical tape.

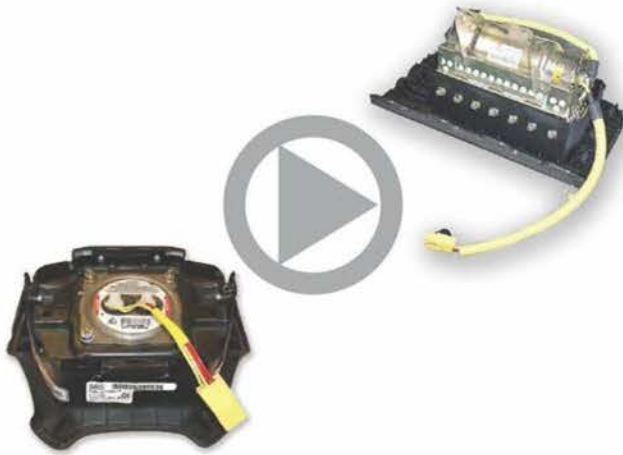
Click on the image below for a short video about the different variations of the driver's and front passenger's replacement inflators involved with the recalls related to inflators. While both the driver's and front passenger's inflators are shown in the video, this is informational only. Replace inflators only as directed by the iN VIN status inquiry.

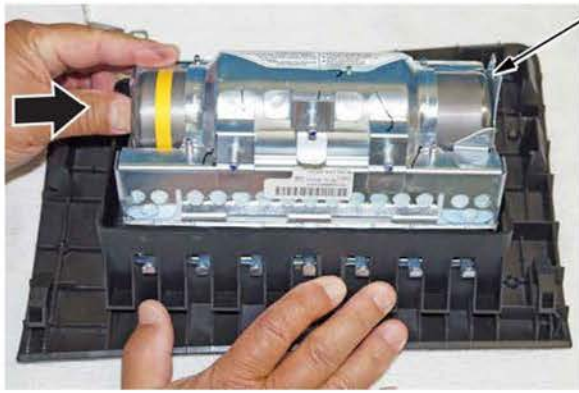
- Slide the inflator in until the “D” aligns with the tab on the inflator bracket. There should be no space or gap between the inflator and bracket.

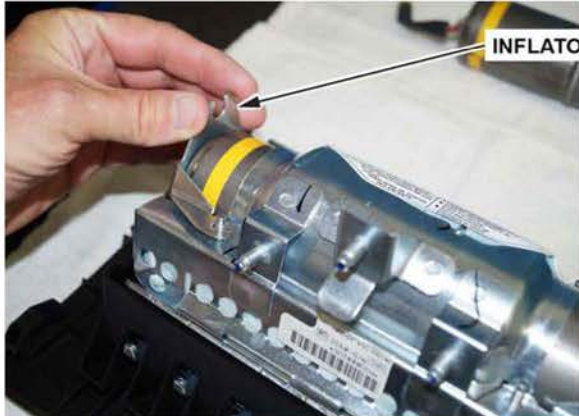
- Reinstall the inflator bracket. There should be no space or gap between the bracket and inflator.

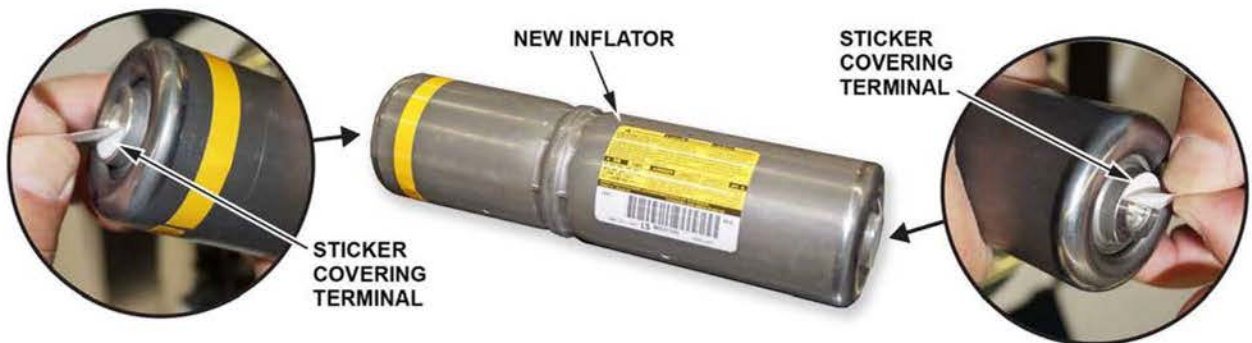
15. Remove the stickers covering the terminals on both sides of the new inflator.

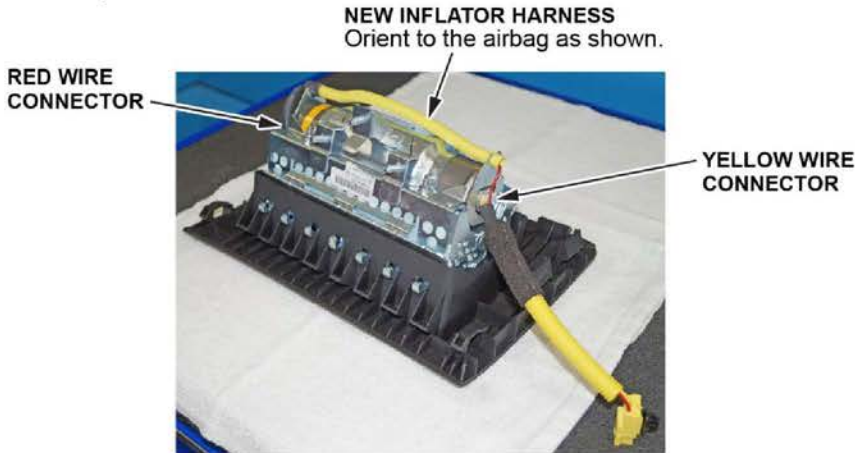
16. Install the new inflator harness.

- Make sure the airbag and harness are aligned as shown.

- **Make sure you have the orientation correct as shown below.** If you connect the harness incorrectly, the harness cannot be removed, and you will not be able to reinstall the airbag because the harness will be too short.
- On the replacement inflators with plastic collars, connect the red wire connector to the connector with the red dot.
- On the replacement inflators without plastic collars, connect the red wire connector to the connector nearest the yellow band.

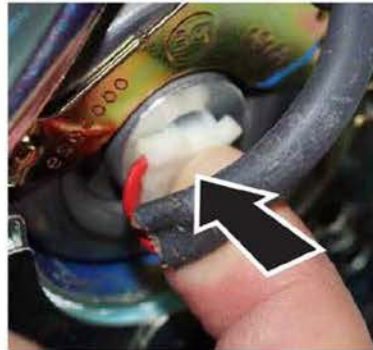
② Press the connector into place until it clicks.

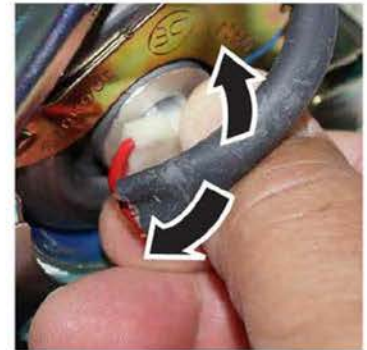
③ Wiggle the connector to make sure it's secure.

- After you hear each connector click, wiggle it to make sure it is secure.

NOTE: If the connector is not properly aligned, it will come out.
