02196 Version 2

Noncompliance Recall: HR-V Emission (Trim and Year), Tire, and A/C Labels

Supersedes 15-054, dated July 24, 2015; see REVISION SUMMARY

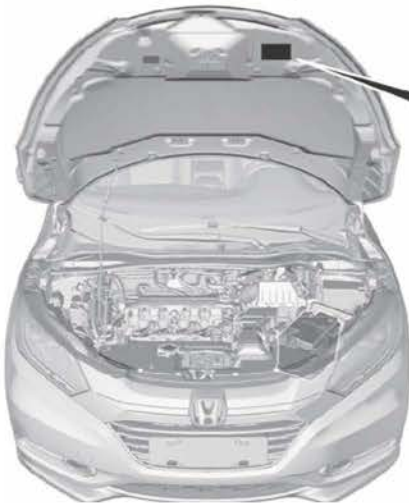
1. Open the hood and make sure the emission label is present at the location shown.

- If the label is present, go to step 2.
- If the label is missing, apply a new one:

- Using alcohol and a clean shop towel, clean the hood area where the emission label is placed. Allow the area to dry.
- Peel off the backing from the emission label, and apply it to the hood. Press the label firmly to make sure it sticks, then go to **A/C Label Inspection and Replacement**.

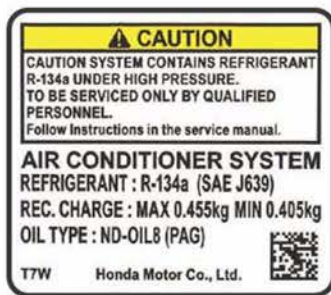
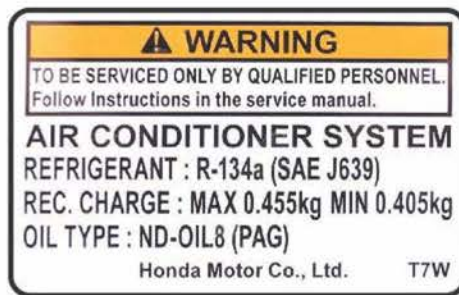
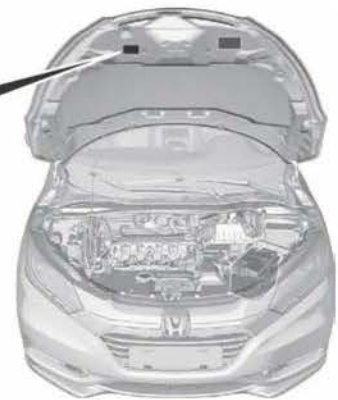
NOTE: Each vehicle should only have 1 A/C label attached to the hood, but because of a change during production, there are 2 different options.

1. Open the hood.
2. Make sure one of the two A/C labels shown below is present on the hood.
 - If the label is present, go to **Tire Label Inspection and Replacement**.
 - If the label is missing, apply a new label:
 - Using alcohol and a clean shop towel, clean the hood area where the A/C label is placed. Allow the surface to dry.
 - Peel off the backing from the A/C label, and apply it to the hood. Press the label firmly to make sure it sticks, then go to **Tire Label Inspection and Replacement**.

There are 2 different label options, but each vehicle should only have one label attached.

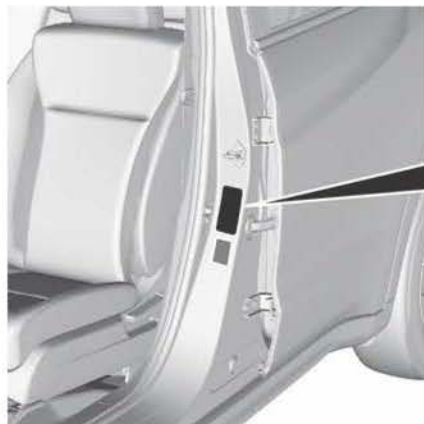
1. Open the driver's door.
2. Make sure the tire label is present on the doorjamb.
 - If the label is present, all the labels are correct. Return the vehicle to the customer.
 - If the label is missing, apply a new label:
 - Using alcohol and a clean shop towel, clean the doorjamb area where the certification label is placed. Allow the surface to dry.
 - Peel off the backing from the tire label, and apply it to the driver's doorjamb. Press the label firmly to make sure it sticks. The labels are correct. Return the vehicle to the customer.

TIRE AND LOADING INFORMATION			
SEATING CAPACITY : TOTAL 5 : FRONT 2 : REAR 3			
The combined weight of occupants and cargo should never exceed 385kg or 850lbs.			
TIRE	SIZE	COLD TIRE PRESSURE	SEE OWNER'S MANUAL FOR ADDITIONAL INFORMATION
FRONT	215/55R17 94V	220KPA, 32PSI	
REAR		210KPA, 30PSI	
SPARE	T135/90D16 102M	420KPA, 60PSI
