July 1, 2015

00406-01910 Version 3

## Safety Recall: Front Passenger's Airbag Inflator May Produce Excessive Pressure After Long-Term Exposure To High Absolute Humidity

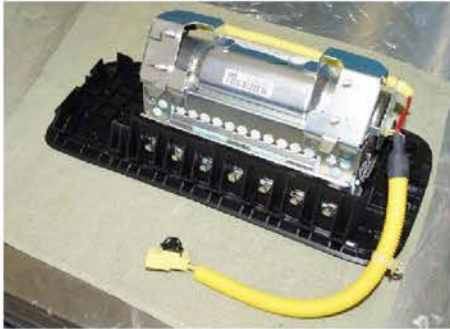
3. Remove the front passenger's airbag by referring to the applicable electronic service manual.
  4. Place the airbag face-down on a clean shop towel as shown.

- The orientation of the airbag is critical because if the inflator is installed incorrectly, the harness will be too short when you reinstall the airbag.
- The brackets between the various models are similar but may differ from the example shown.

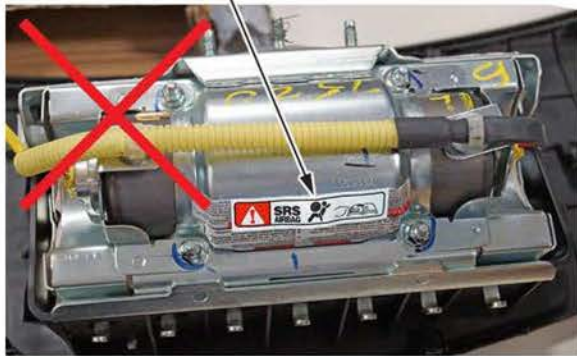
NON-STANDARD SAFETY LABEL

5. Visually inspect the airbag and the inflator for any unusual writing or markings.

- If there is nothing unusual about the airbag or the inflator, go to step 6.
- If there are any unusual markings, like an incorrect label or a model year written in marker, the airbag and inflator may not be the correct airbag and/or inflator for the vehicle or it may be a counterfeit part. For more information about counterfeit airbags, you can refer to [safercar.gov](http://safercar.gov), enter keywords **MANAGING COUNTERFEIT**, and select **Recommended Dealer Guidance for Managing Counterfeit Air Bags** from the list. **If you suspect that the airbag or inflator is counterfeit, do not continue this procedure.** Contact your DPSM for assistance.

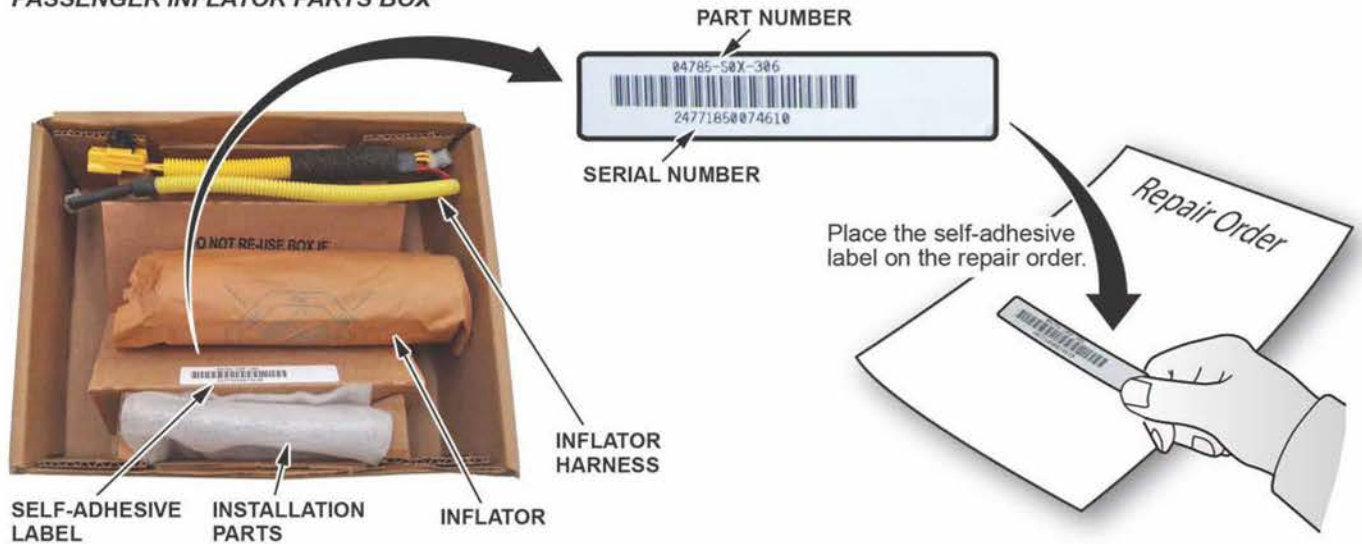
**PASSENGER INFLATOR PARTS BOX**

6. Peel the label located inside the inflator box from its backing and attach it to the R.O. For the warranty claim to be paid, the **replacement inflator part number that you received** must be on the warranty claim and your warranty clerk must enter the serial number in the Diagnostic Trouble Codes field.

- The replacement part number is printed on the top part of the label and the serial number is printed on the bottom. **Make sure you attach the label to the R.O. and give it to the warranty clerk.**
- There may also be a colored sticker located in the kit, ignore it because it is not used.
- Not all inflator kits have a label included. In those cases, write the serial number and part number from the side of the inflator box on the R.O. The part number always starts with 047.

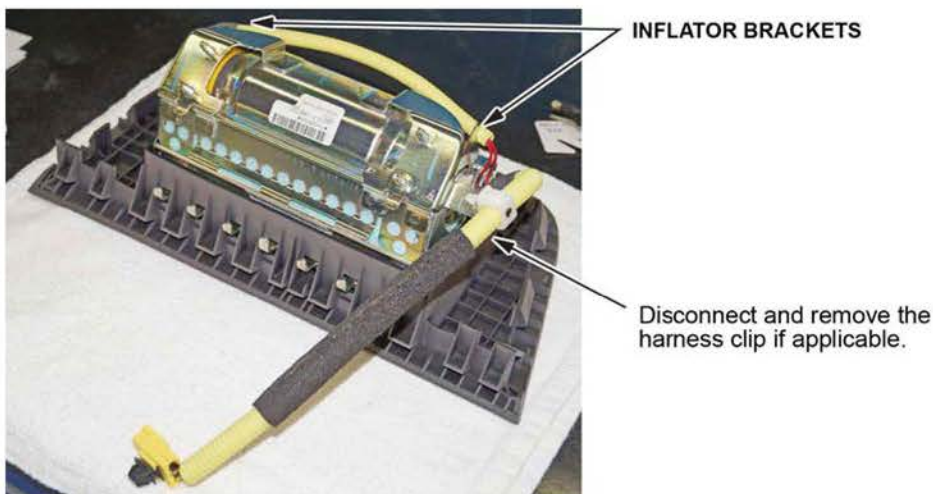
7. Remove the harness from both ends of the inflator bracket.

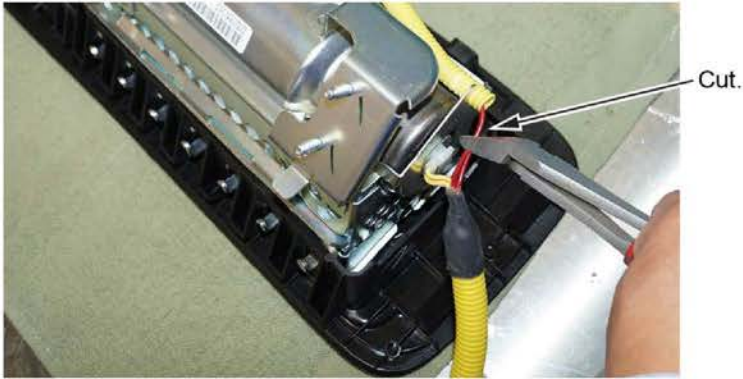
8. Short the red wires.

NOTE: You must cut and short the wires as indicated to prevent accidental deployment.

- Cut the red wires as shown.

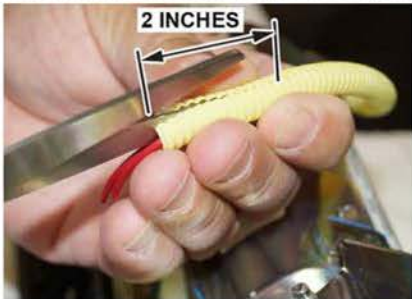
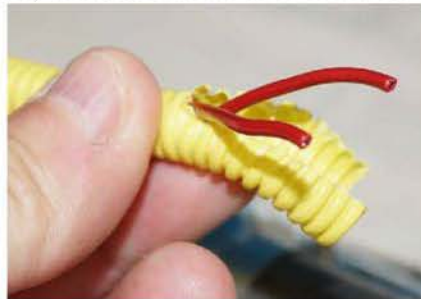
- Cut about 2 inches of the corrugated tube, then pull out the two red wires.

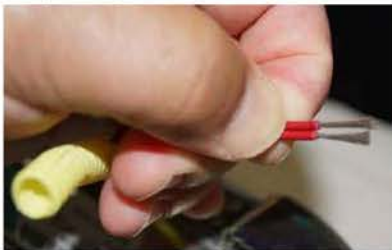
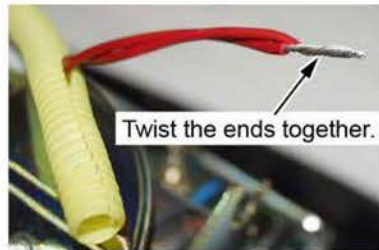
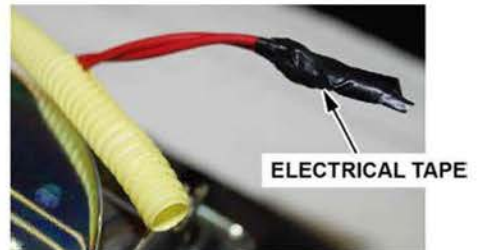
- Strip away about 1 inch of the wire insulation, then twist the wires together.

- Tape the twisted ends with electrical tape.

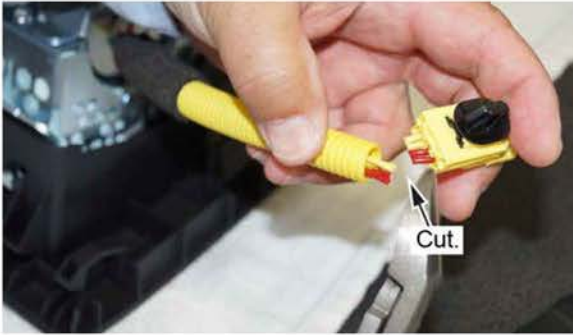
9. Cut off the connector and short the yellow wires.

You must cut and short the wires as indicated to prevent accidental deployment.

- Cut all four wires to remove the connector.

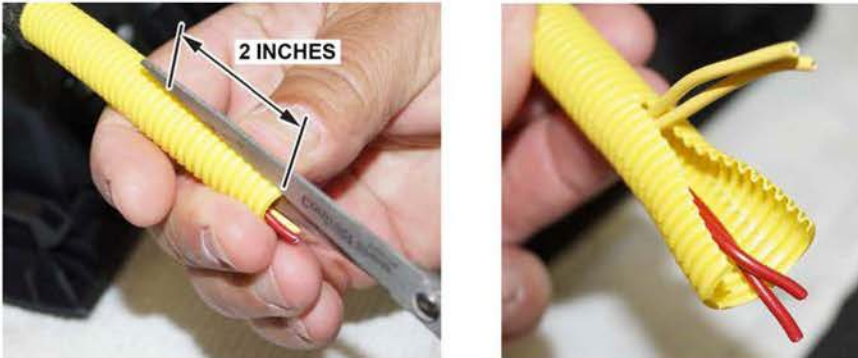
- Cut about 2 inches of the corrugated tube, then pull out the yellow wires.

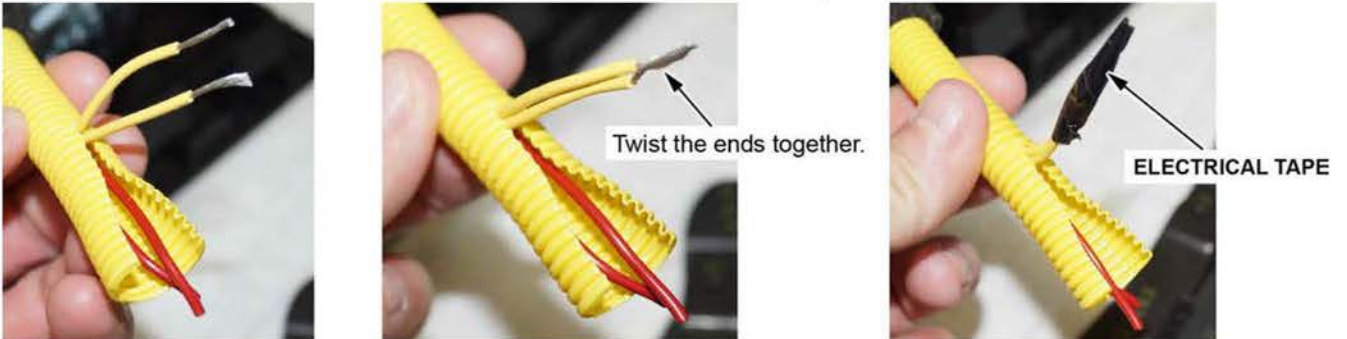
- Strip away about an inch of the wire insulation, then twist the wires together.

- Tape the twisted ends with electrical tape.

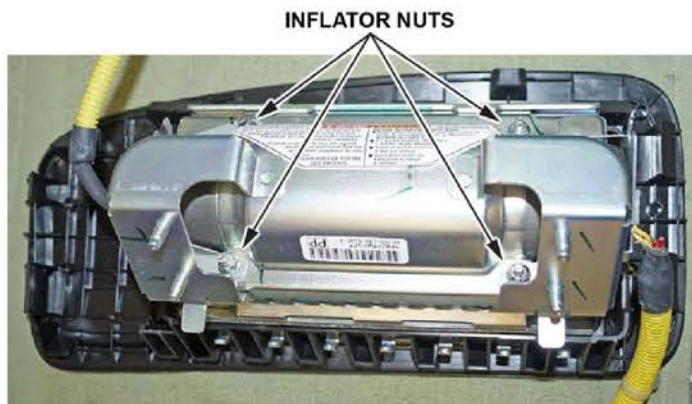
10. Remove the four inflator nuts.

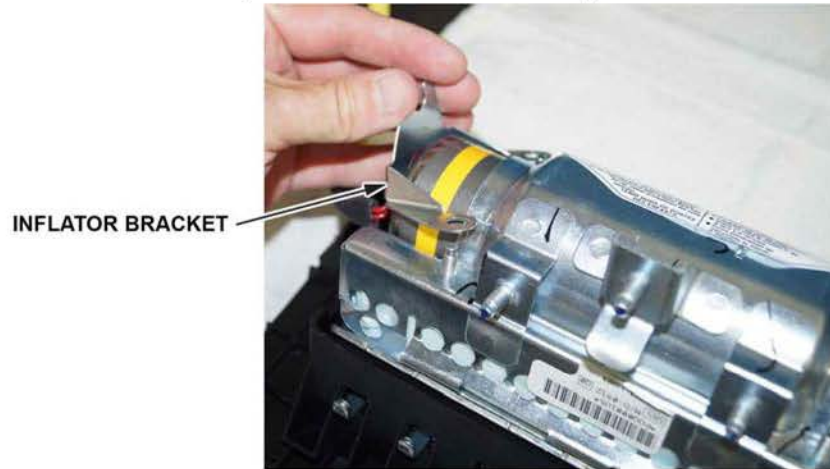
11. Remove the inflator bracket.

NOTE: You can only remove one of the brackets, as the other is welded to the airbag housing.

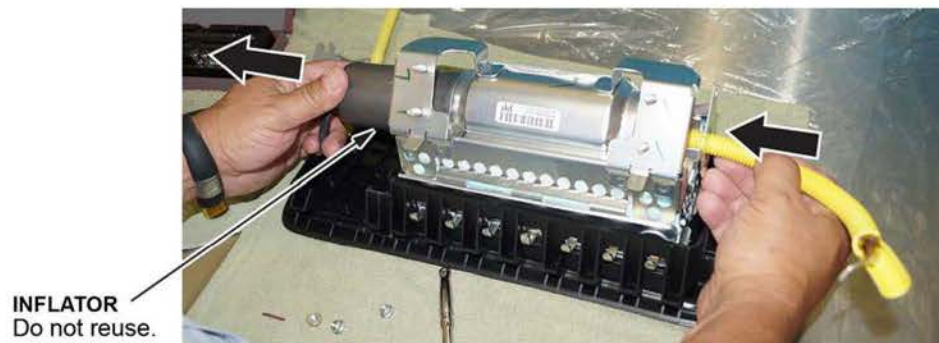
12. Remove the inflator by pushing it out.

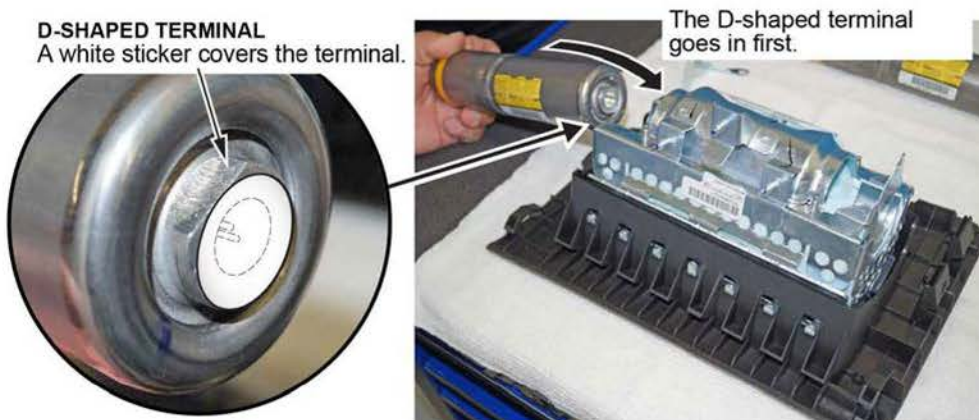
- One connector looks like a “D” whereas the other connector is a circle. Make sure you insert the “D” connector into the airbag first.

NOTE: There is a yellow band marking on the circle side.

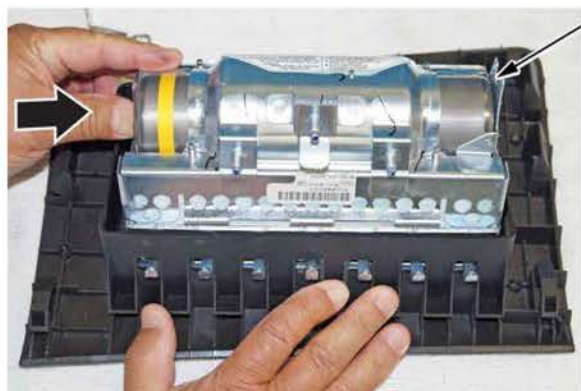
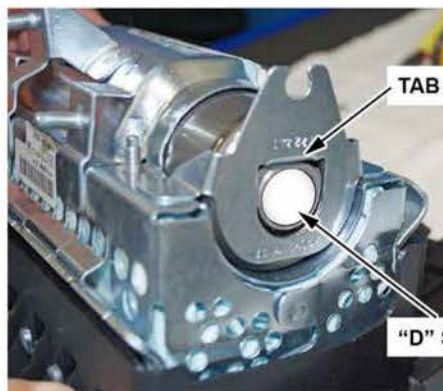
No gap.

- Slide the inflator in until the “D” aligns with the tab on the inflator bracket. There should be no space or gap between the inflator and bracket.

TAB ON BRACKET

"D" SHAPED END

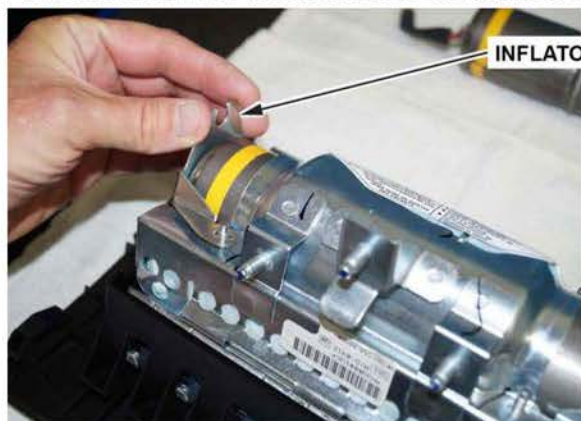
INFLATOR BRACKET

- Reinstall the inflator bracket. There should be no space or gap between the bracket and inflator.

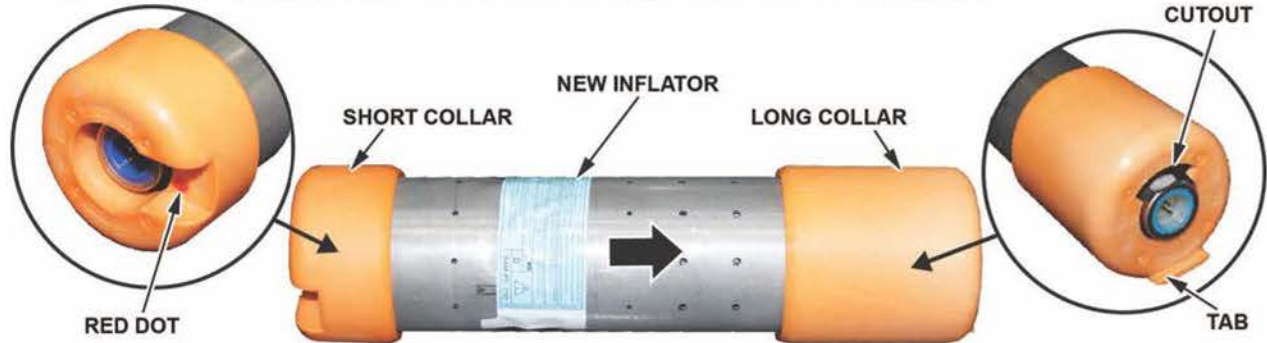
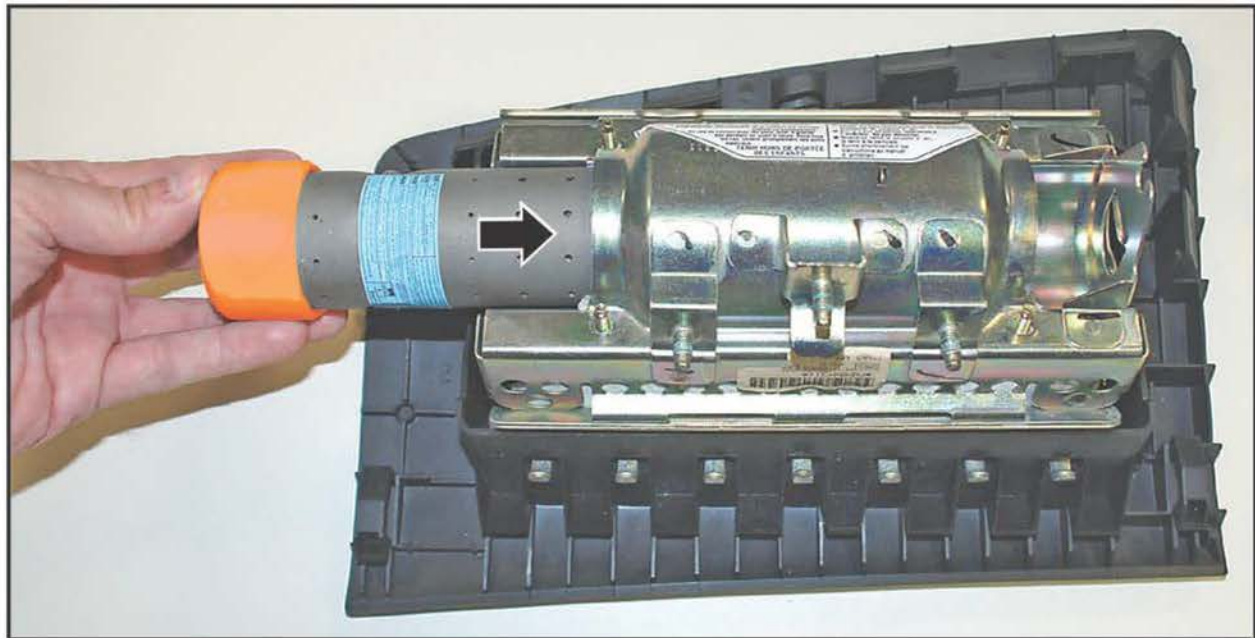
- The collars on this inflator are orange, not white. One side of the inflator has a longer collar, a tab, a plastic cutout, and a small flat spot on the connector. The other side of the inflator has a shorter collar, no tab, and a red dot. Make sure you insert the end with the longer collar into the airbag first.

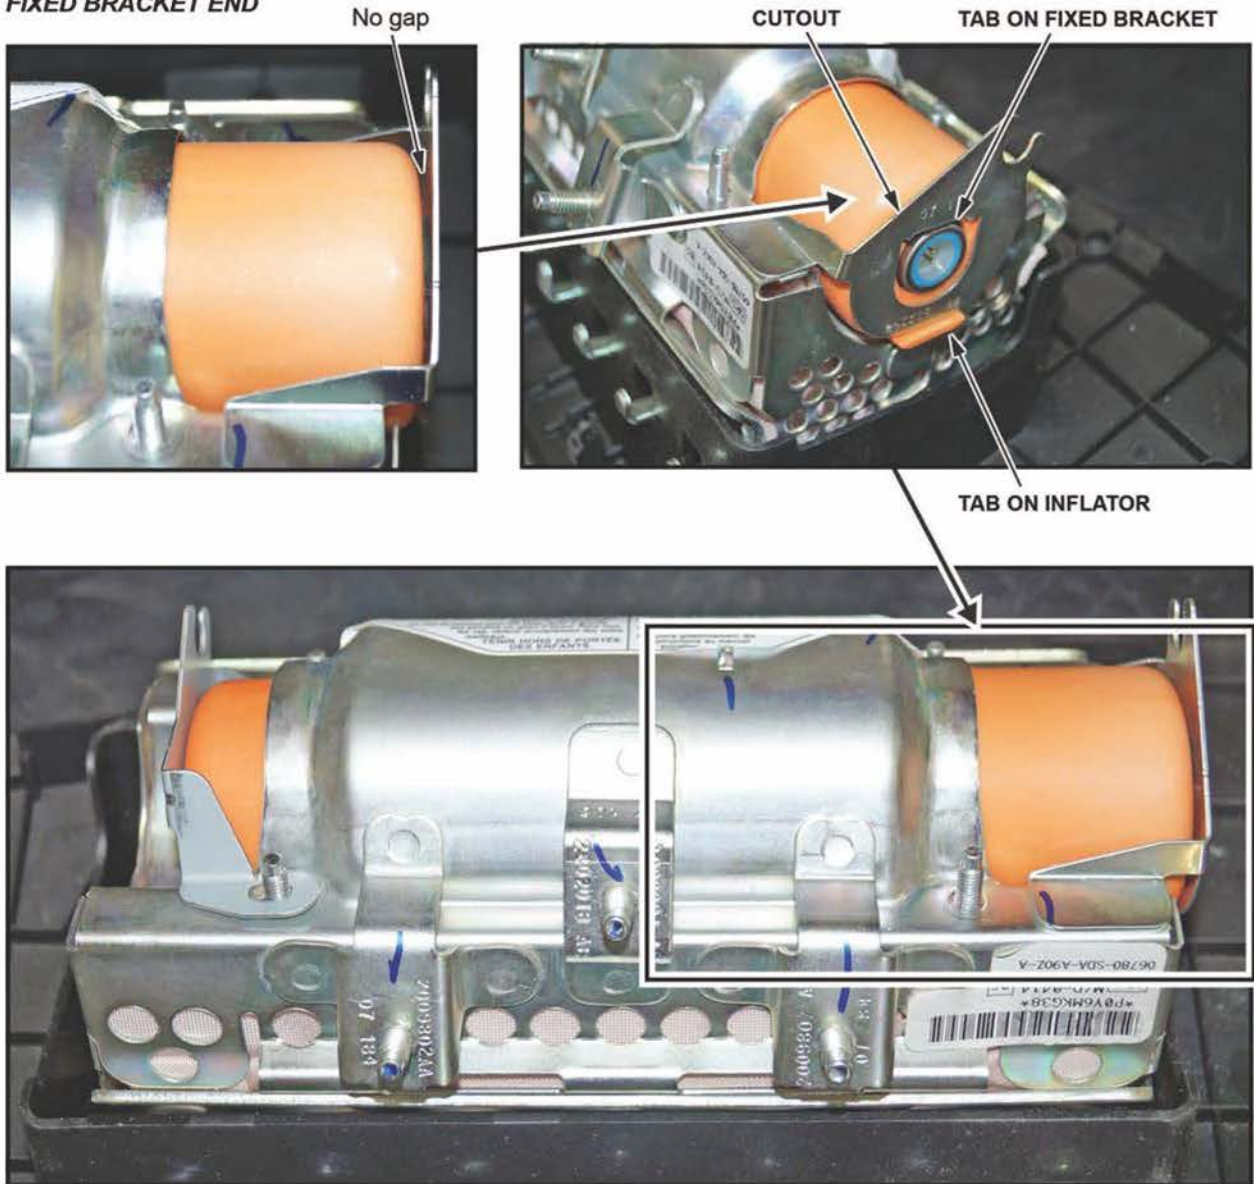
**FIXED BRACKET END**

- Slide the inflator in until the plastic cutout and the small flat spot align with the tab on the bracket. There should be no space or gap between the inflator and bracket.

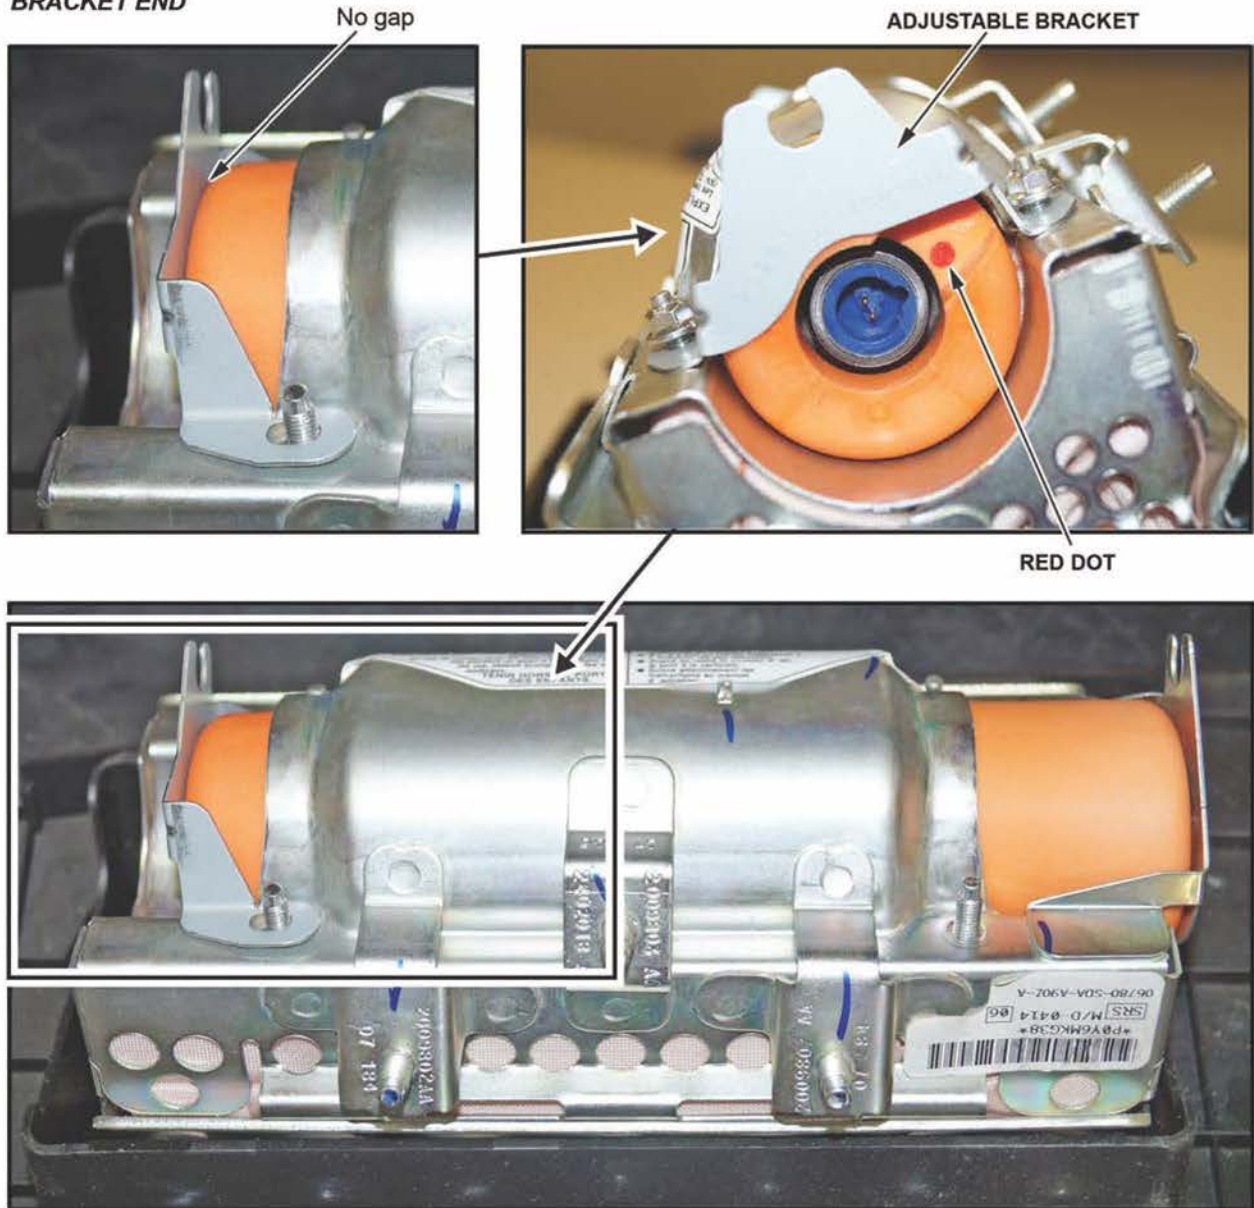
**ADJUSTABLE  
BRACKET END**

- Install the bracket included in the kit onto the airbag module. There should be a red dot visible on the end of the plastic connector. There should be no space or gap between the inflator and bracket.

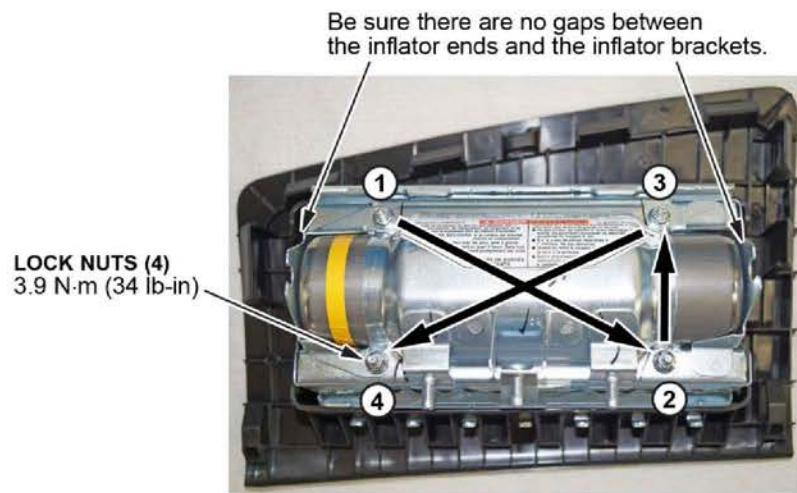
14. Install the new 5 mm locknuts and torque them in sequence to **3.9 N·m (34 lb-in)**.

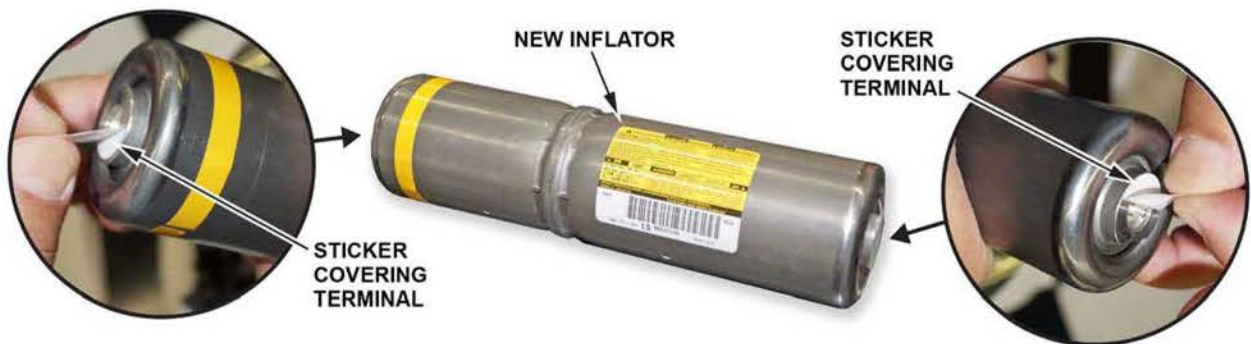
15. Remove the stickers covering the terminals on both sides of the new inflator.

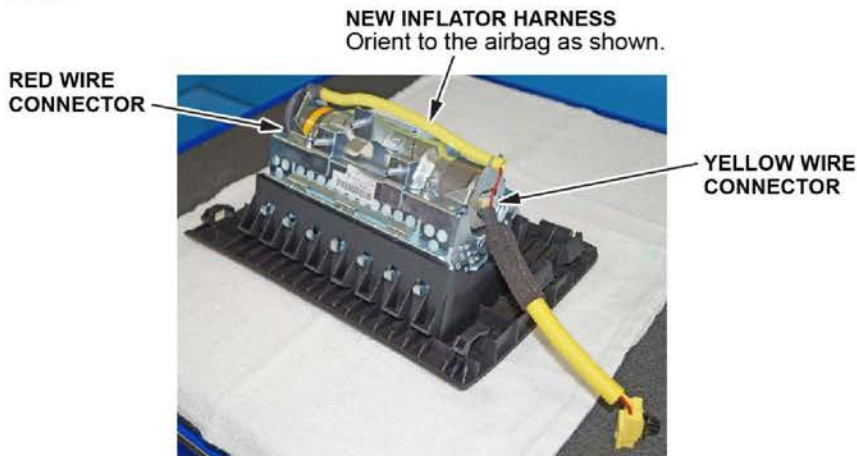
16. Install the new inflator harness.

- Make sure the airbag and harness are aligned as shown.

NOTE: Make sure you have the orientation correct as shown below. If you connect the harness incorrectly, the harness cannot be removed, and you will not be able to reinstall the airbag because the harness will be too short.

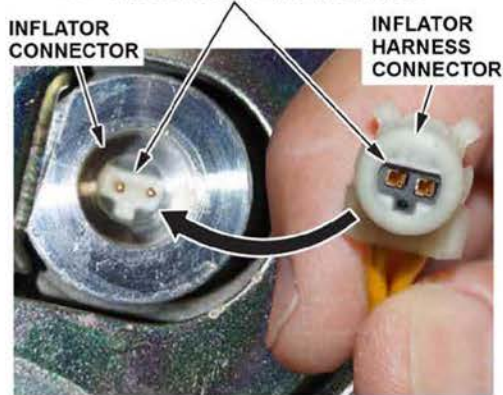
- Connect the two connectors. Align the "T" shape in the inflator harness connector with the T-shaped inflator connector, then press the connector into place.

① Match up the "T" shape as shown. The connectors are directional.

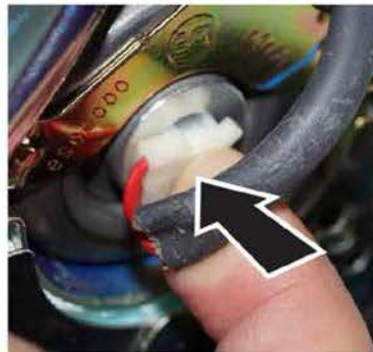
② Press the connector into place until it clicks.

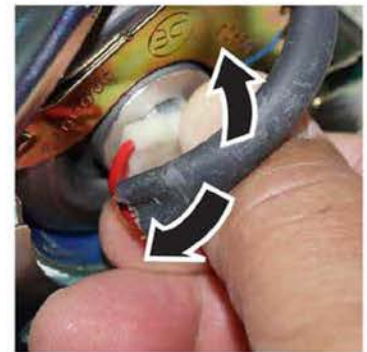
③ Wiggle the connector to make sure it's secure.

- After you hear each connector click, wiggle it to make sure it is secure. NOTE: If the connector is not properly aligned, it will come out.

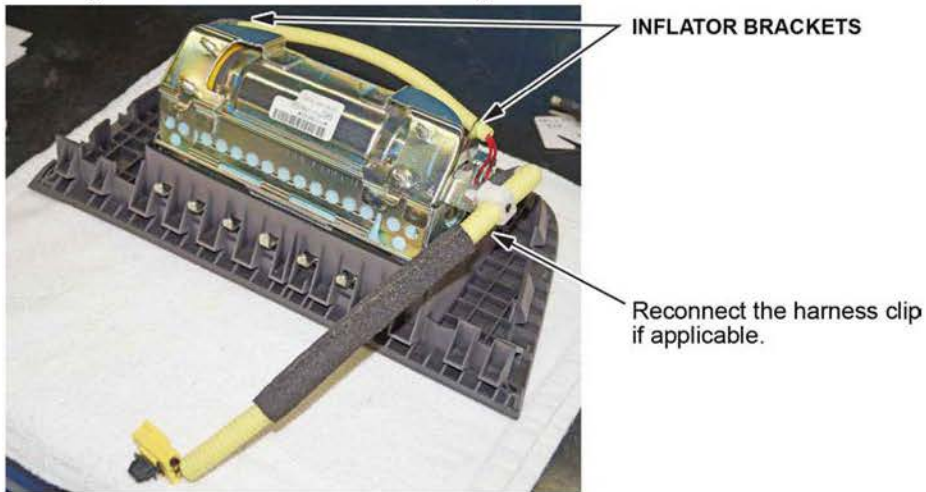
17. Connect the harness to the inflator brackets.

- Insert the side without the shrink-wrap tubing first. Insert the harness at the third “valley” in the corrugated tube.
- Insert the side of the harness with the shrink-wrap tubing into the inflator bracket. Make sure the harness is securely inserted and that it does not sag.
