June 9, 2015

02025 Version 1

Safety Recall: Driver's Airbag Inflator Can Be Over-Pressurized

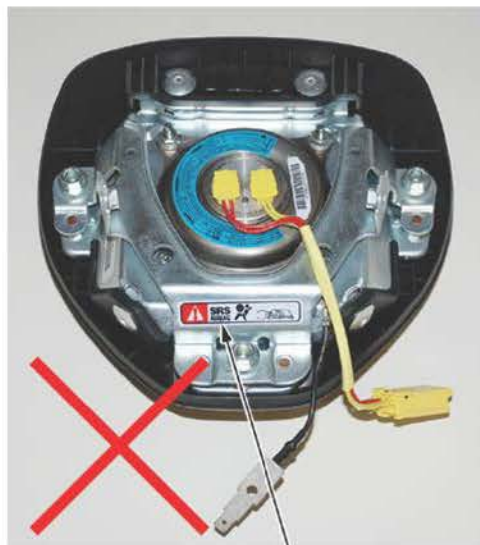
NON-STANDARD
SAFETY LABEL

- If there are any unusual markings, like an incorrect label or a model year written in marker, the airbag and inflator may not be the correct airbag and/or inflator for the vehicle or it may be a counterfeit part. For more information about counterfeit airbags, you can refer to safercar.gov, enter keywords **MANAGING COUNTERFEIT**, and select **Recommended Dealer Guidance for Managing Counterfeit Air Bags** from the list. **If you suspect that the airbag or inflator is counterfeit, do not continue this procedure.** Contact your DPSM for assistance.

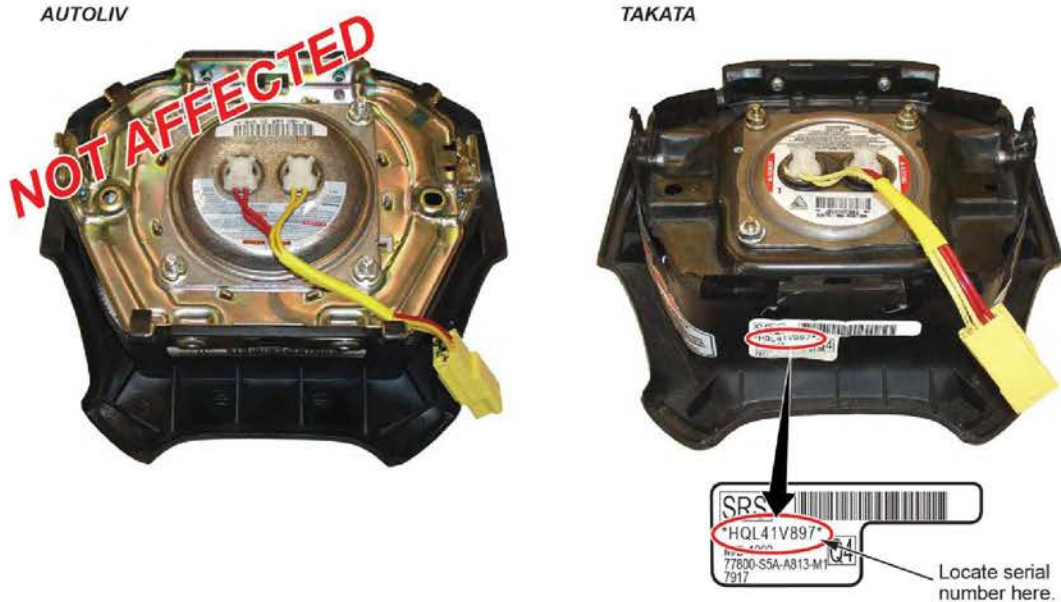
6. **Civic only** - Determine if the airbag is made by Autoliv or Takata by comparing the inflators to those in the images below.

NOTE: The Autoliv serial number label is different from the Takata label; the Autoliv has 11 characters, the Takata has 9.

- If the airbag is made by Autoliv, the airbag is OK. Reinstall the airbag using new Torx bolts. Torque the bolts to **9.8 N-m (7.2 lb-ft)**. If you already received a replacement inflator, return the unopened kit to American Honda.
- If the airbag is made by Takata, go to step 8.

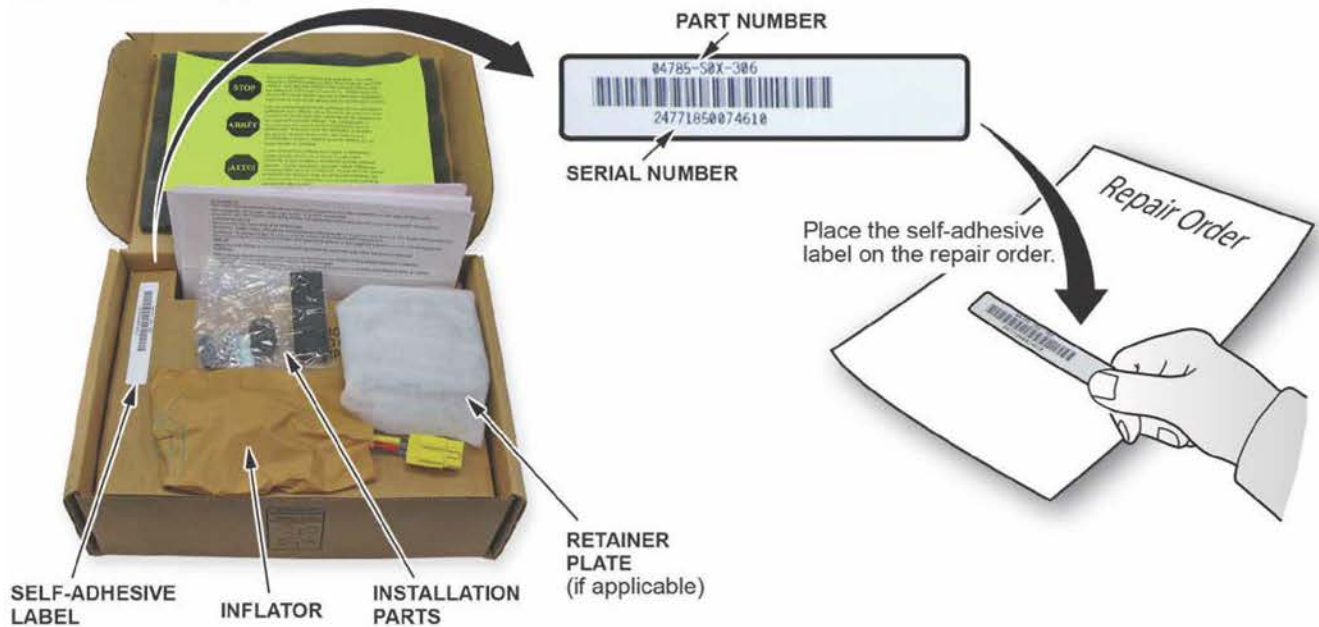
INFLATOR PARTS BOX

7. Peel the label located inside the inflator box from its backing and attach it to the R.O. For the warranty claim to be paid, the **replacement inflator part number that you received** must be on the warranty claim and your warranty clerk must enter the serial number in the Diagnostic Trouble Codes field.

- The replacement part number is printed on the top part of the label and the serial number is printed on the bottom. **Make sure you attach the label to the R.O. and give it to the warranty clerk.**
- There may also be a colored sticker located in the kit, ignore it because it is not used.
- Not all inflator kits have a label included. In those cases, write the serial number and part number from the side of the inflator box on the R.O. The part number always starts with 047.

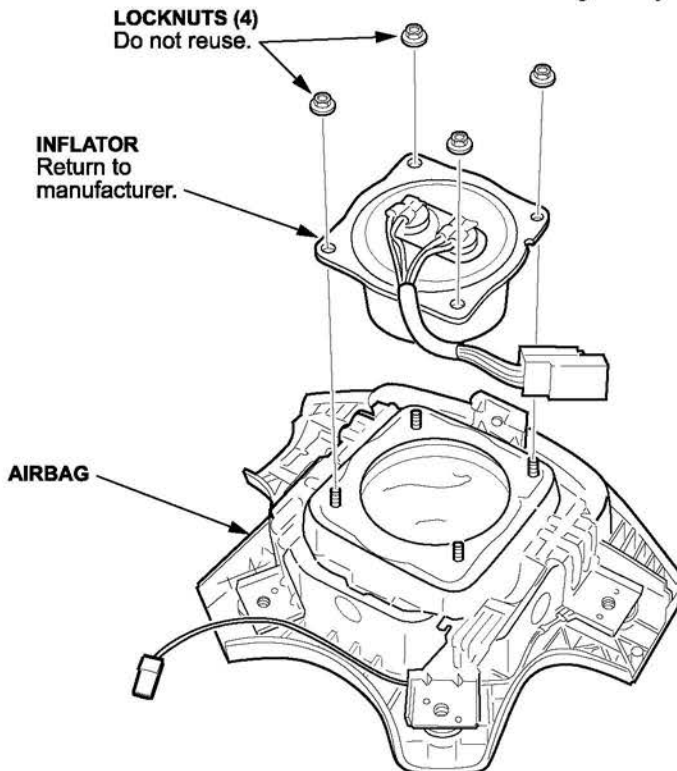
9. Using needle-nose vise grips or a 3/8 in. 6-point socket, remove the four locknuts from the inflator. The locknuts will not be reused.

NOTE: Do not remove the inflator from the airbag until you complete step 10.

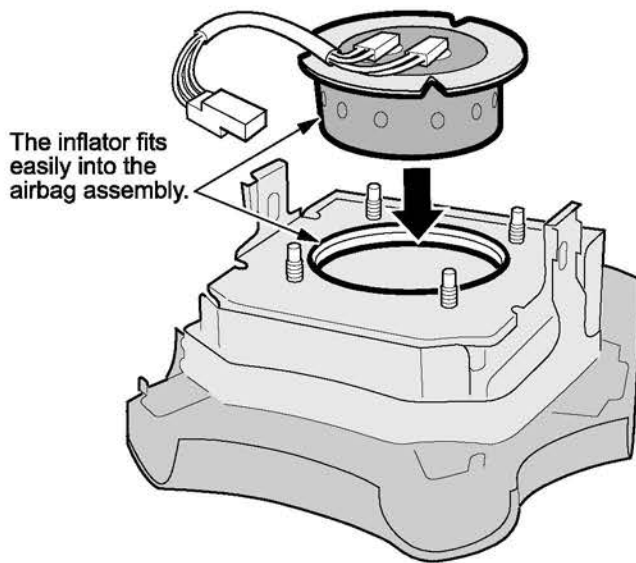
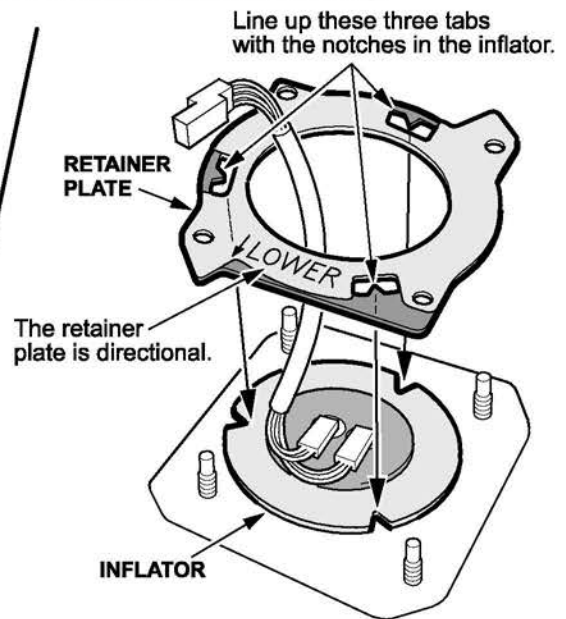
- Install the bracket onto the studs with the stamp **LOWER** at the bottom of the airbag.
- Make sure the three tabs and notches are properly aligned.

- The tabs and notches are designed to align in one direction only. If the tabs and notches are not aligned, the inflator and bracket are not installed correctly.
- Make sure the harness comes out through the center opening. Do not install the bracket over the harness wires.
