June 5, 2015

02025 Version 1

Safety Recall: Driver's Airbag Inflator Can Be Over-Pressurized

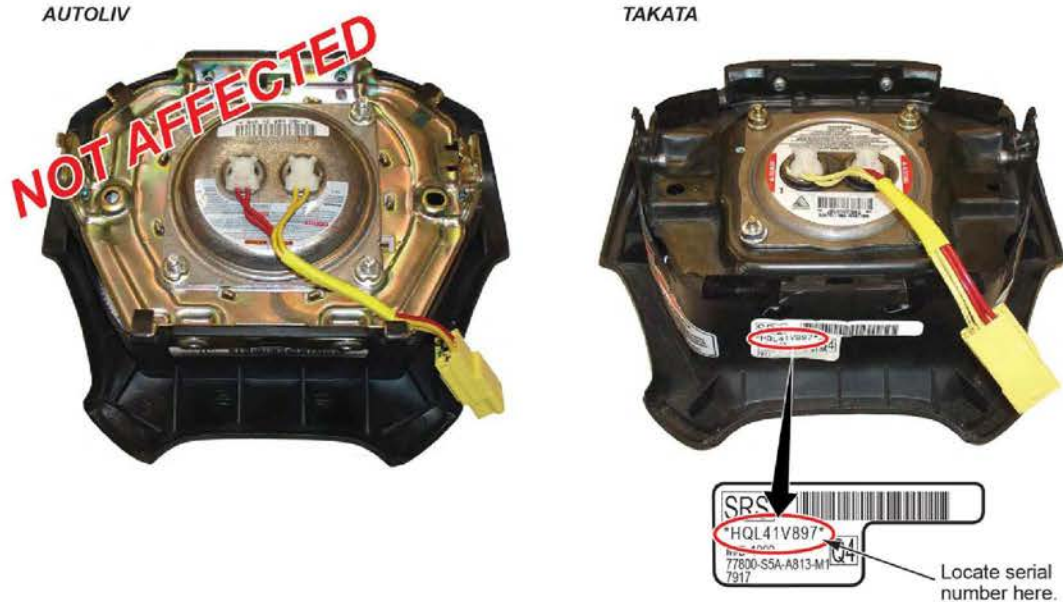
6. **Civic only** - Determine if the airbag is made by Autoliv or Takata by comparing the inflators to those in the images below.

NOTE: The Autoliv serial number label is different from the Takata label; the Autoliv has 11 characters, the Takata has 9.

- If the airbag is made by Autoliv, the airbag is OK. Reinstall the airbag using new Torx bolts. Torque the bolts to **9.8 N·m (7.2 lb-ft)**. If you already received a replacement inflator, return the unopened kit to American Honda.
- If the airbag is made by Takata, go to step 8.

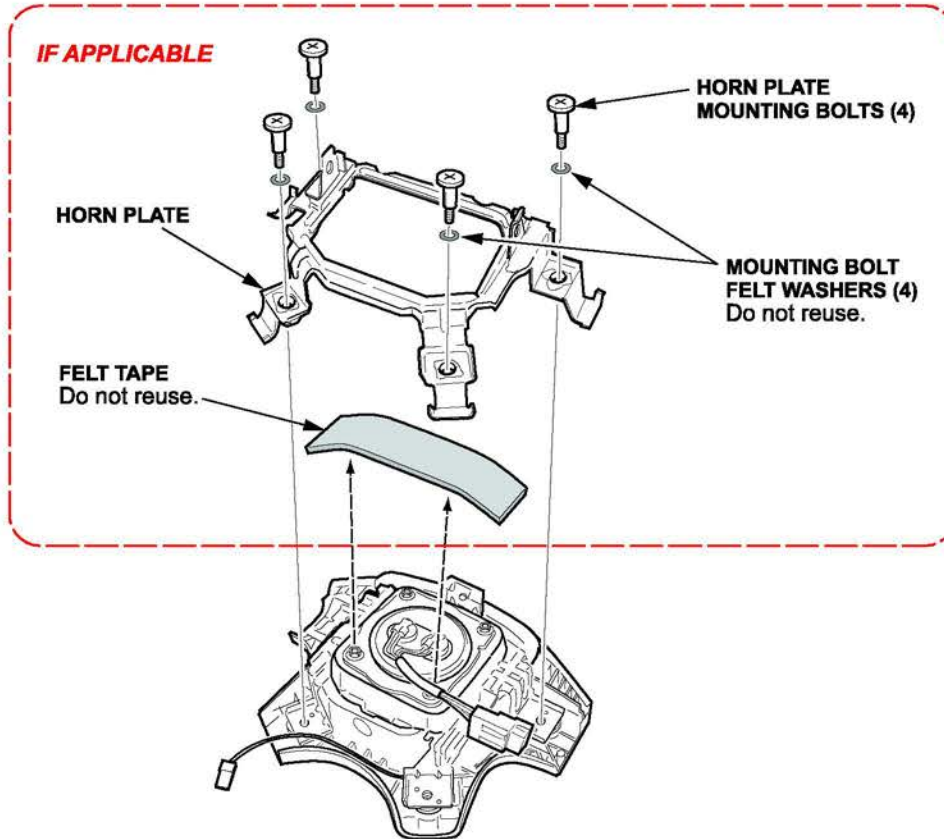
8. If there is no horn plate installed, go to step 9. If there is a horn plate installed, remove the four horn plate mounting bolts, the mounting bolt felt washers, the horn plate, and remove the felt tape covering the lower two inflator locknuts. The felt washers and felt tape will not be reused.
