# Service Bulletin

*15-033*

## Safety Recall: Driver's Airbag Inflator Can Be Over-Pressurized

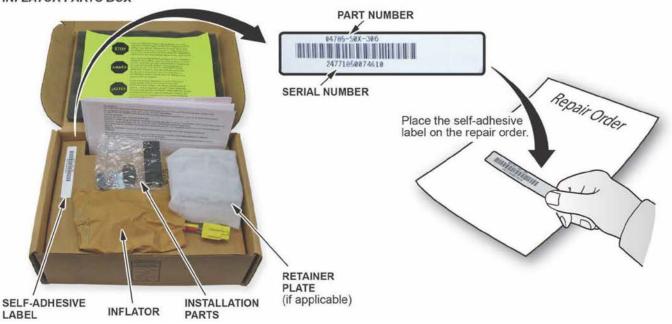
#### **INFLATOR PARTS BOX**

- The replacement part number is printed on the top part of the label and the serial number is printed on the bottom. Make sure you attach the label to the R.O. and give it to the warranty clerk.
- There may also be a colored sticker located in the kit, ignore it because it is not used.
- Not all inflator kits have a label included. In those cases, write the serial number and part number from the side
  of the inflator box on the R.O. The part number always starts with 047.

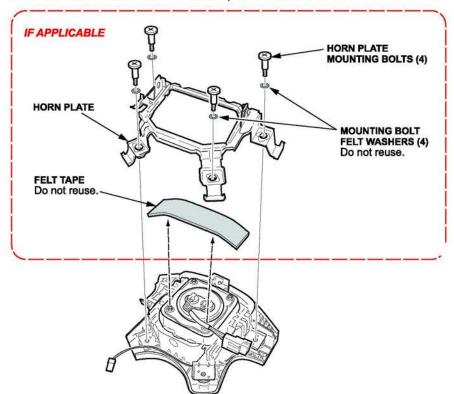
7. If there is no horn plate installed, go to step 8. If there is a horn plate installed, remove the four horn plate mounting bolts, the mounting bolt felt washers, the horn plate, and remove the felt tape covering the lower two inflator locknuts. The felt washers and felt tape will not be reused.

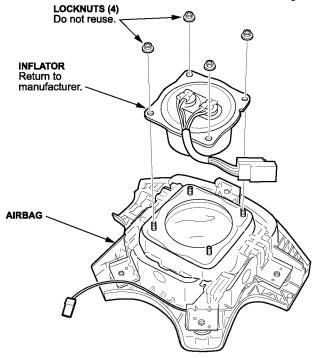
8. Using needle-nose vise grips or a 3/8 in. 6-point socket, remove the four locknuts from the inflator. The locknuts will not be reused.

NOTE: Do not remove the inflator from the airbag until you complete step 9.

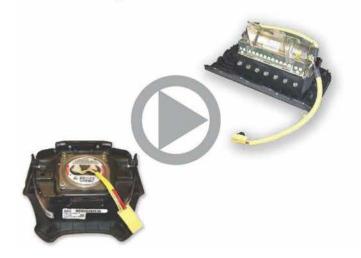
NOTE: There may be some minor surface rust or corrosion on the new inflator; this is OK. Click on the image below for a short video about the different inflators.

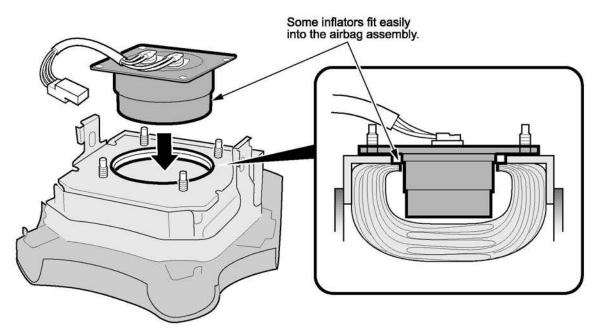
· Insert the inflator into the opening.

NOTE: Make sure the inflator wires are positioned toward the bottom of the airbag. If you install the inflator incorrectly, you may not be able to reconnect the SRS airbag harness.

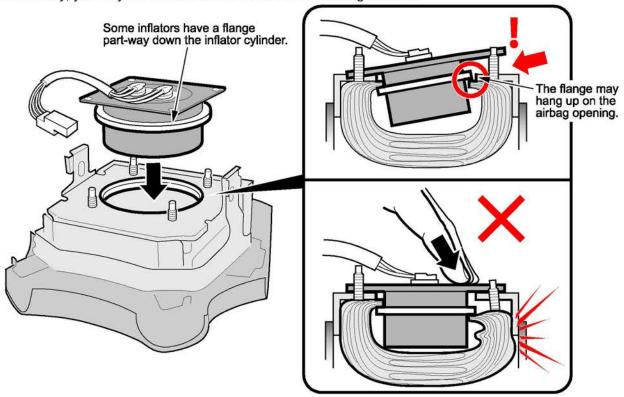
Insert the airbag inflator into the opening. Do not force it into the airbag module.

NOTE: Make sure the inflator wires are positioned toward the bottom of the airbag. If you install the inflator incorrectly, you may not be able to reconnect the SRS airbag harness.

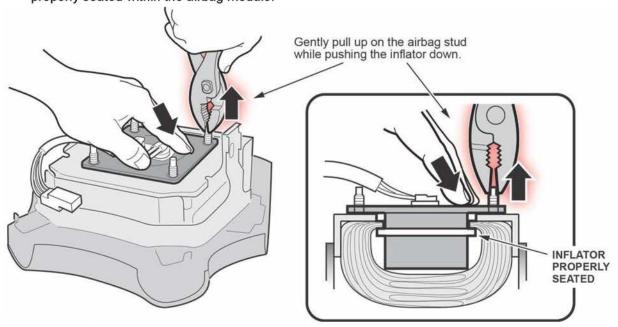
Using a pair of pliers, gently pull up on each stud up while pushing the inflator module down until the airbag is
properly seated within the airbag module.

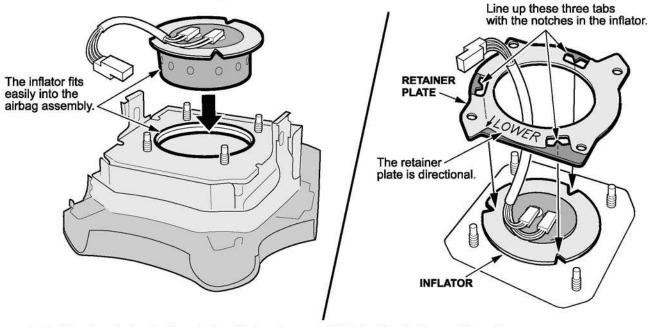
Place the inflator into the opening with the inflator harness toward the bottom of the airbag.

- Install the bracket onto the studs with the stamp LOWER at the bottom of the airbag.
- Make sure the three tabs and notches are properly aligned.

- The tabs and notches are designed to align in one direction only. If the tabs and notches are not aligned, the inflator and bracket are not installed correctly.
- Make sure the harness comes out through the center opening. Do not install the bracket over the harness wires.
