ATB 51971-01939 Version 9

## Recall: Driver's Airbag Inflator May Produce Excessive Pressure After Long-Term Exposure to High Absolute Humidity

Supersedes 14-045, dated April 24, 2015, to revise the information highlighted in **yellow**

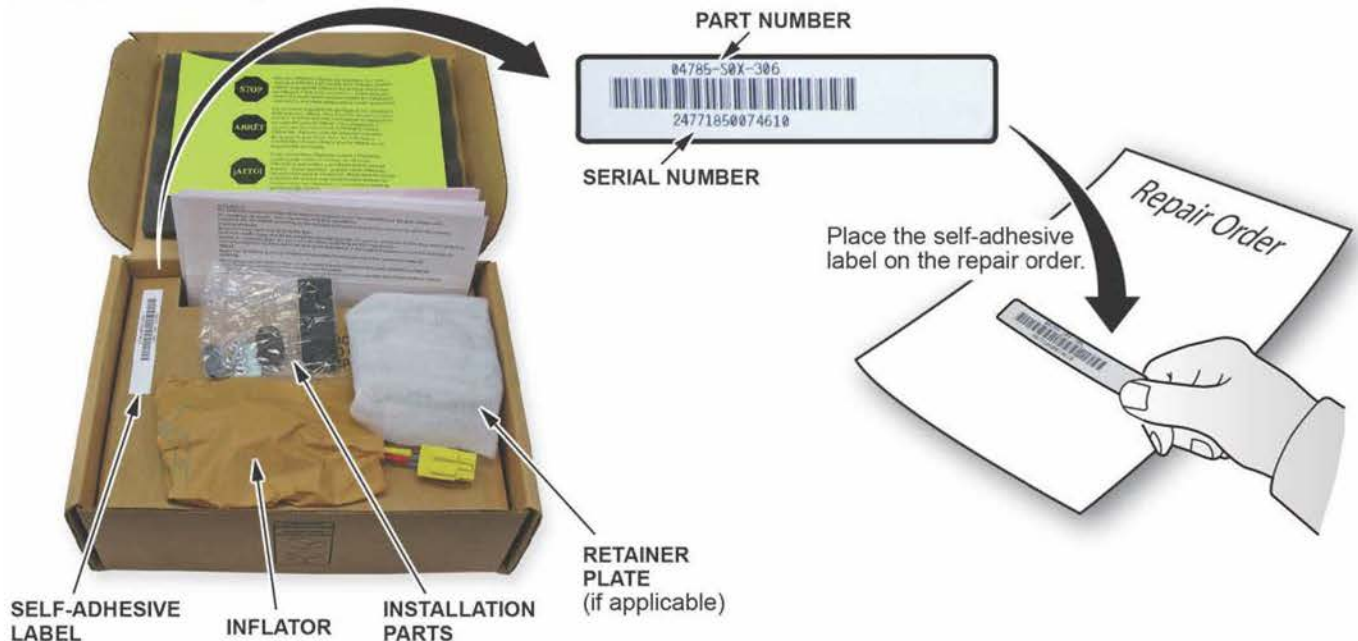
### INFLATOR PARTS BOX

- The replacement part number is printed on the top part of the label and the serial number is printed on the bottom. **Make sure you attach the label to the R.O. and give it to the warranty clerk.**
- There may also be a colored sticker located in the kit, ignore it because it is not used.
- Not all inflator kits have a label included. In those cases, write the serial number and part number from the side of the inflator box on the R.O. The part number always starts with 047.

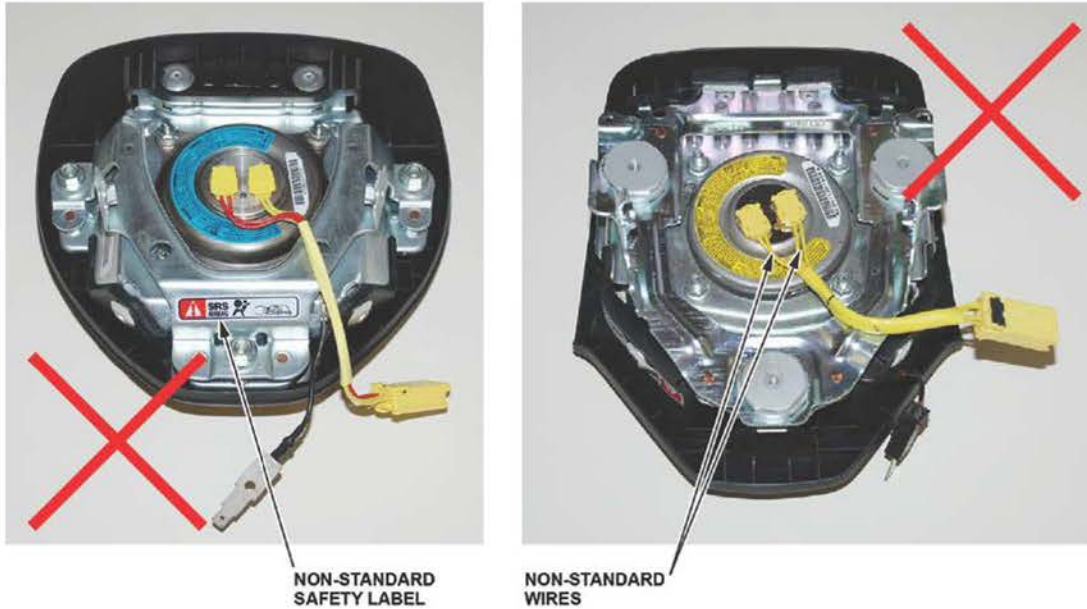
4. Visually inspect the airbag and the inflator for any unusual writing or markings.
  - If there is nothing unusual about the airbag or the inflator, go to step 5.
  - If there are any unusual markings, like an incorrect label or a model year written in marker, the airbag and inflator may not be the correct airbag and/or inflator for the vehicle or it may be a counterfeit part. For more information about counterfeit airbags, you can refer to [safercar.gov](http://safercar.gov), enter keywords **MANAGING COUNTERFEIT**, and select **Recommended Dealer Guidance for Managing Counterfeit Air Bags** from the list. **If you suspect that the airbag or inflator is counterfeit, do not continue this procedure.** Contact your DPSM for assistance.

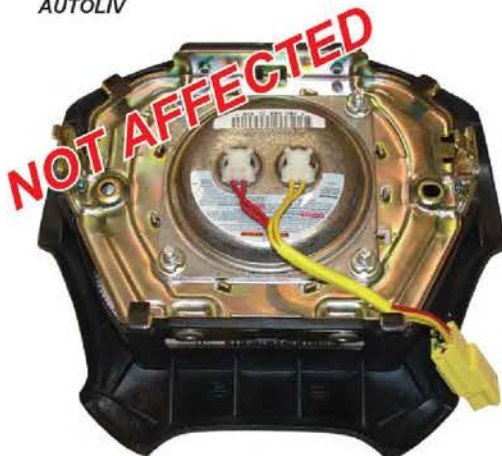
AUTOLIV

5. **Civic only** - Determine if the airbag is made by Autoliv or Takata by comparing the inflators to those in the images below.

NOTE: The Autoliv serial number label is different from the Takata label; the Autoliv has 11 characters, the Takata has 9.

- If the airbag is made by Autoliv, the airbag is OK. Reinstall the airbag using new Torx bolts. Torque the bolts to **9.8 N·m (7.2 lb-ft)**. If you already received a replacement inflator, return the unopened kit to American Honda.
- If the airbag is made by Takata, go to step 6.

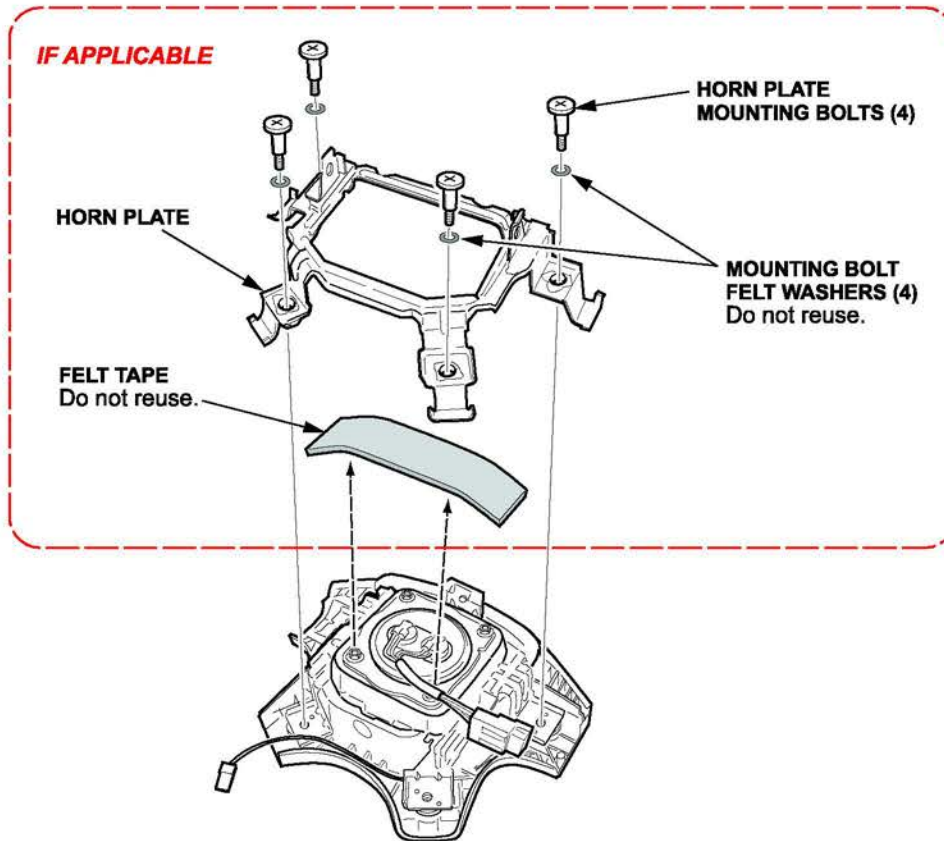
6. If there is no horn plate installed, go to step 7. If there is a horn plate installed, remove the four horn plate mounting bolts, the mounting bolt felt washers, the horn plate, and remove the felt tape covering the lower two inflator locknuts. The felt washers and felt tape will not be reused.

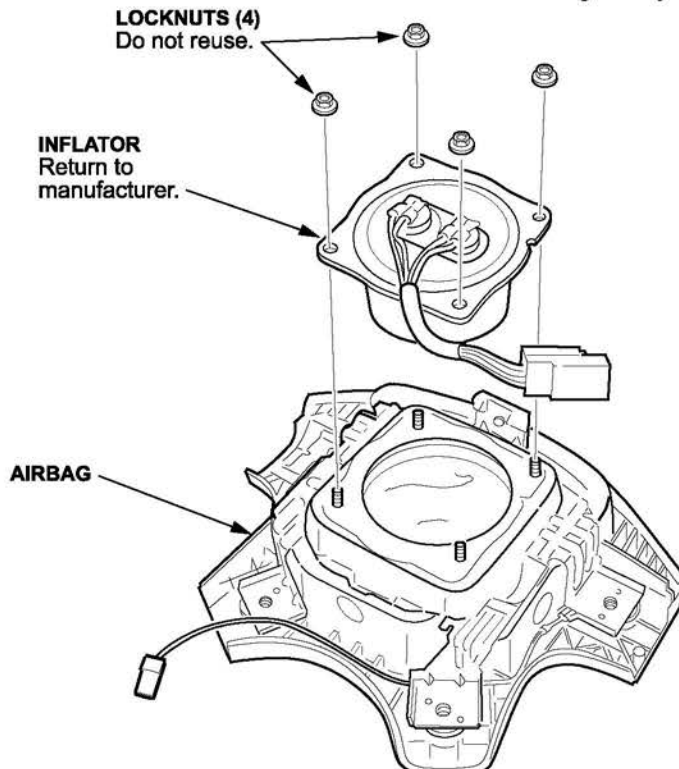
7. Using needle-nose vise grips or a 3/8 in. 6-point socket, remove the four locknuts from the inflator. The locknuts will not be reused.

NOTE: Do not remove the inflator from the airbag until you complete step 8.

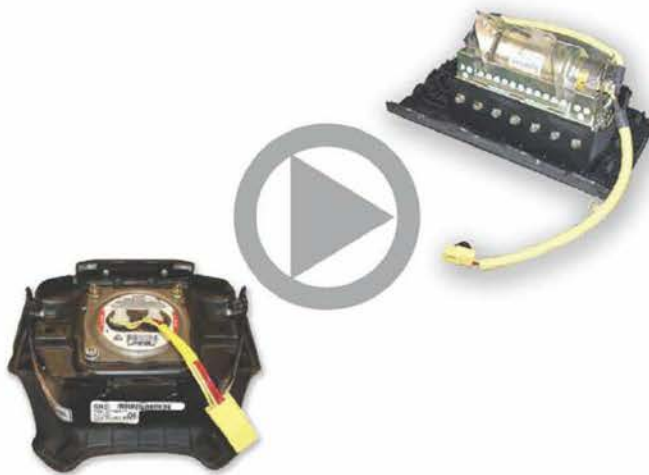
Click on the image below for a short video about the different variations of the driver's and front passenger's replacement inflators involved with the recalls related to Takata inflators. While both the driver's and front passenger's inflators are shown in the video, this is informational only. Replace inflators only as directed by the iN VIN status inquiry.

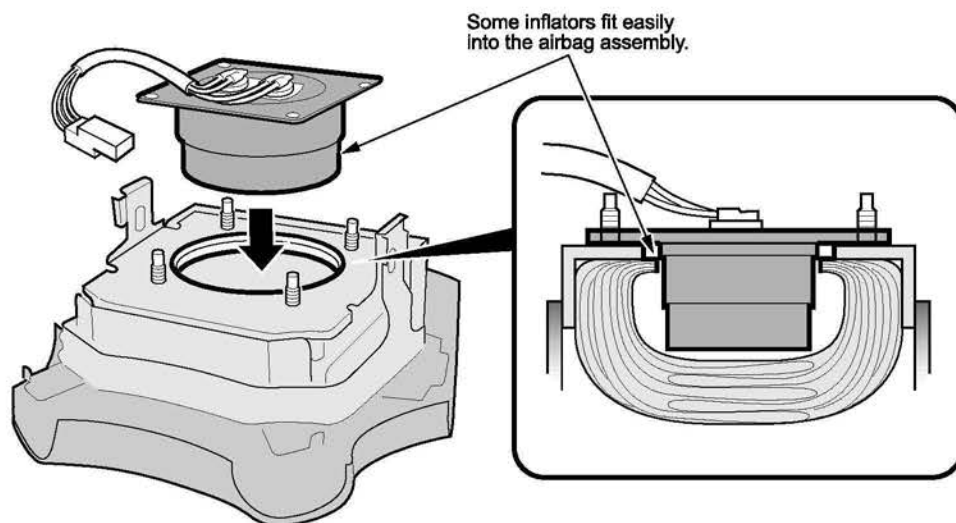
- Insert the inflator into the opening.

NOTE: Make sure the inflator wires are positioned toward the bottom of the airbag. If you install the inflator incorrectly, you may not be able to reconnect the SRS airbag harness.

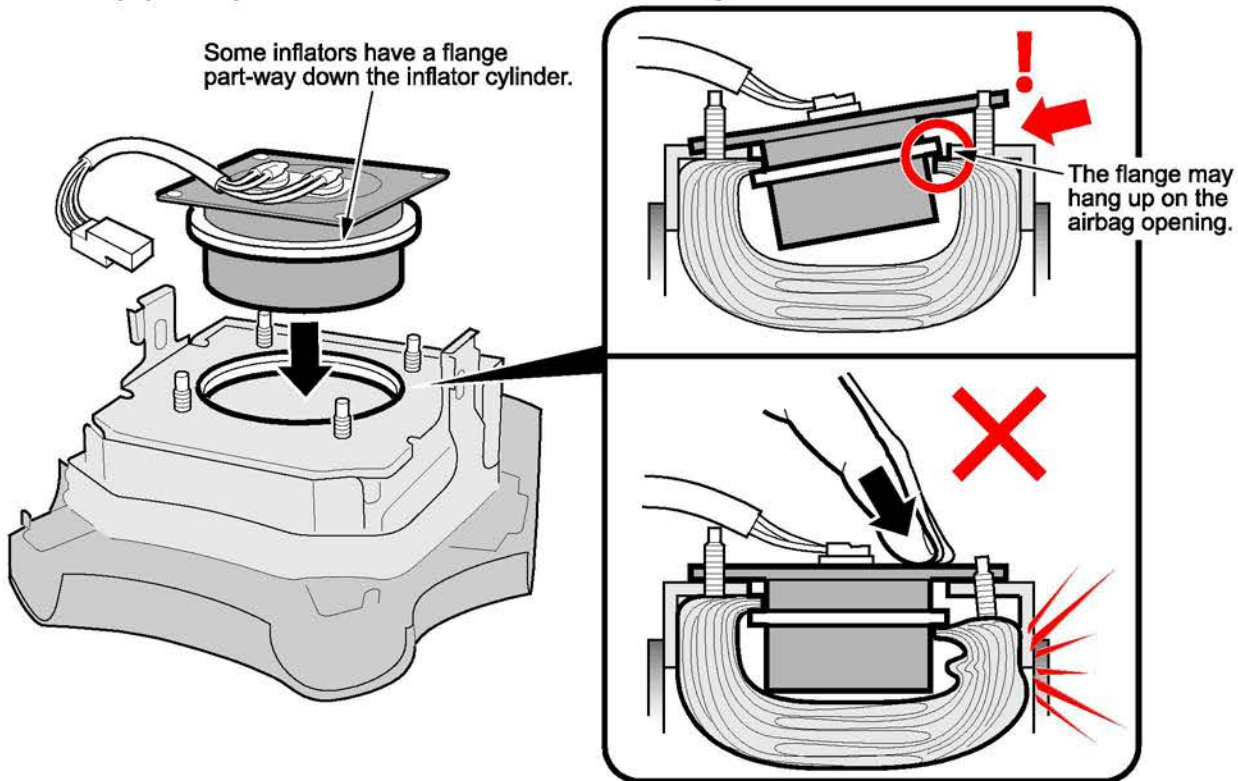
- Insert the airbag inflator into the opening. Do not force it into the airbag module.

NOTE: Make sure the inflator wires are positioned toward the bottom of the airbag. If you install the inflator incorrectly, you may not be able to reconnect the SRS airbag harness.

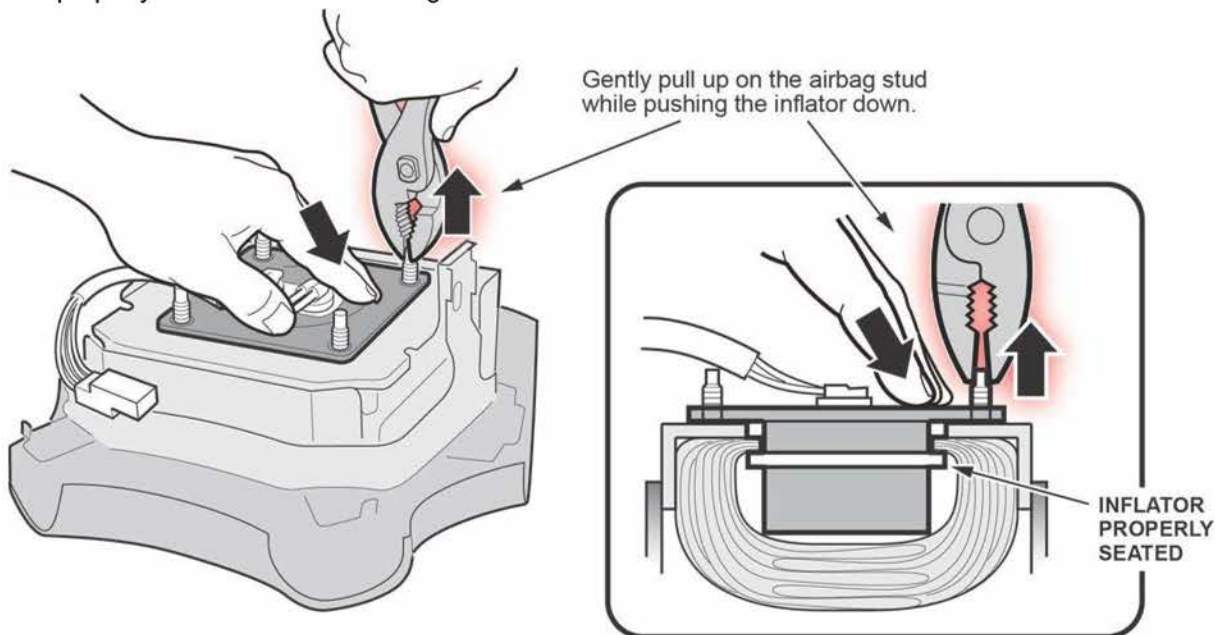
- Using a pair of pliers, gently pull up on each stud up while pushing the inflator module down until the airbag is properly seated within the airbag module.

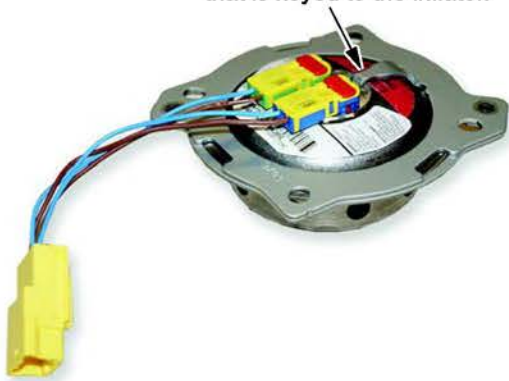
The inflator is held down by a directional retainer that is keyed to the inflator.

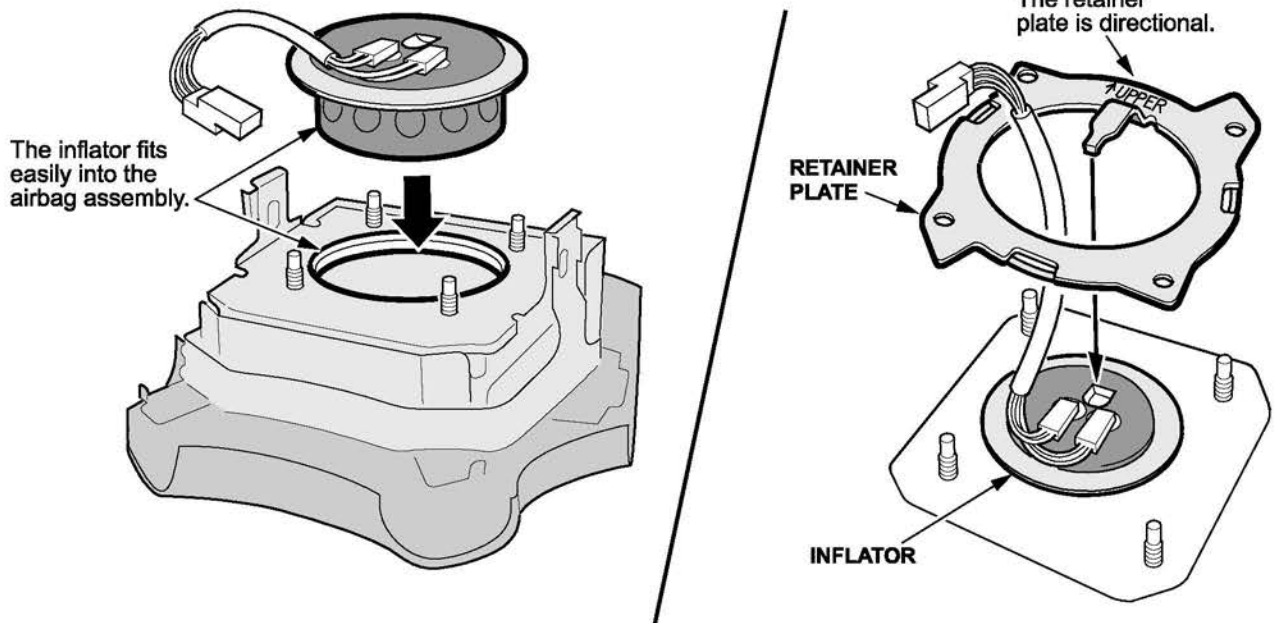
- Place the inflator into the opening with the inflator harness toward the bottom of the airbag.

- Install the bracket onto the studs. Make sure the locator tab fits into the locator hole as shown.  
NOTE: Make sure the harness comes out through the center opening. Do not install the bracket over the harness wires.

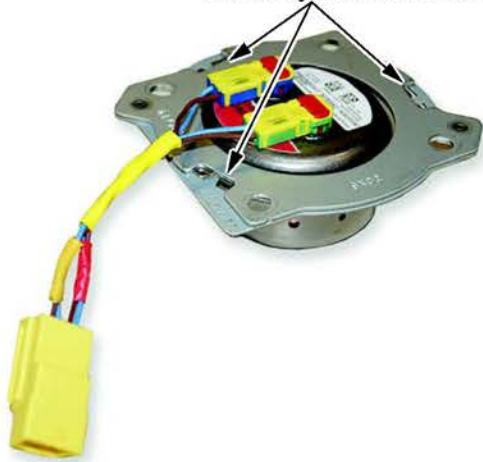
The inflator is held down by a directional retainer that is keyed to the inflator.

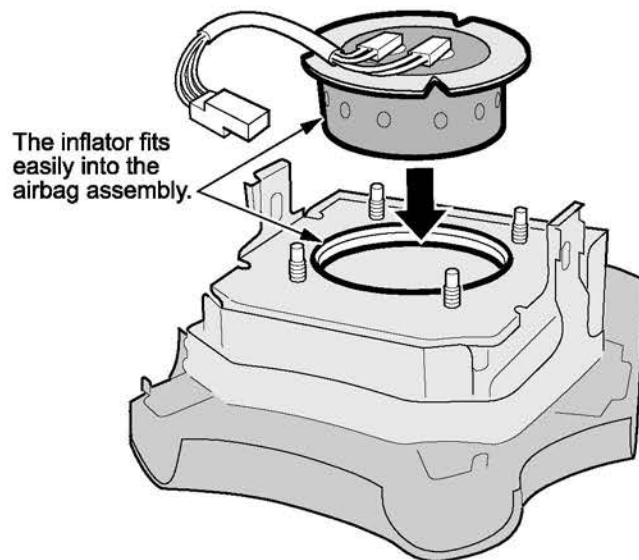
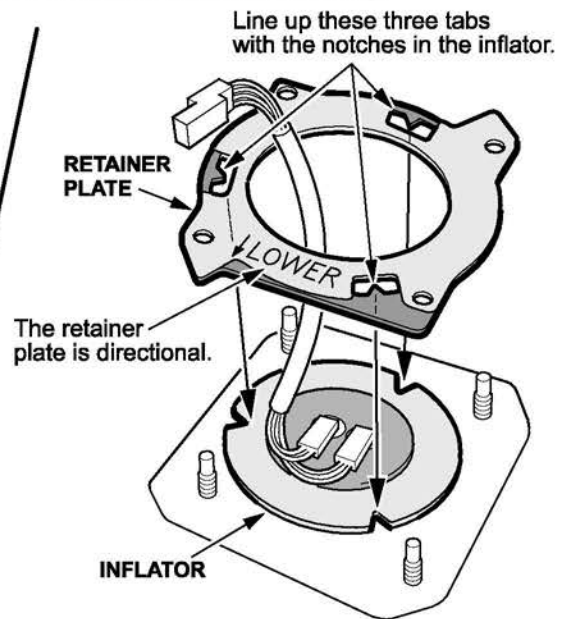
- Place the inflator into the opening with the inflator harness toward the bottom of the airbag.

- Install the bracket onto the studs with the stamp **LOWER** at the bottom of the airbag.
- Make sure the three tabs and notches are properly aligned.

- The tabs and notches are designed to align in one direction only. If the tabs and notches are not aligned, the inflator and bracket are not installed correctly.
- Make sure the harness comes out through the center opening. Do not install the bracket over the harness wires.
