51971-01938 Version 9

## Safety Recall: Replacement Driver's Airbag Inflator Can Be Over-Pressurized

### AFFECTED VEHICLES

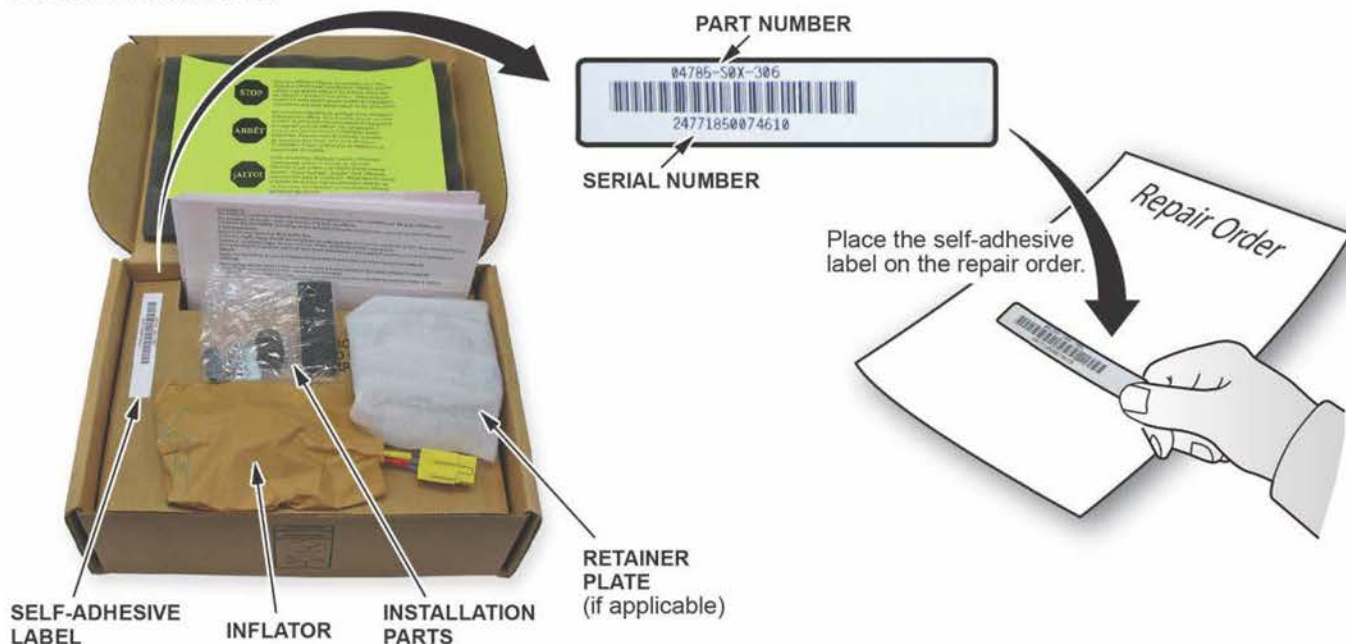
### INFLATOR PARTS BOX

- The replacement part number is printed on the top part of the label and the serial number is printed on the bottom. **Make sure you attach the label to the R.O. and give it to the warranty clerk.**
- There may also be a colored sticker located in the kit, ignore it because it is not used.
- Not all inflator kits have a label included. In those cases, write the serial number and part number from the side of the inflator box on the R.O. The part number always starts with 047.

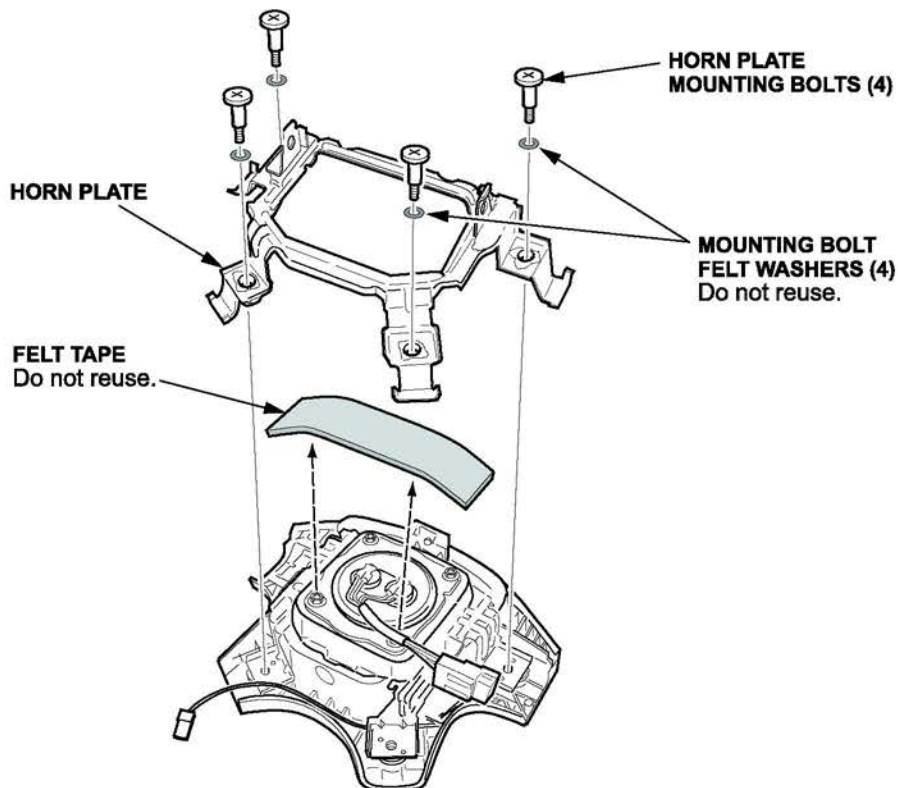
5. Remove the four horn plate mounting bolts, the mounting bolt felt washers, and the horn plate. The felt washers will not be reused.

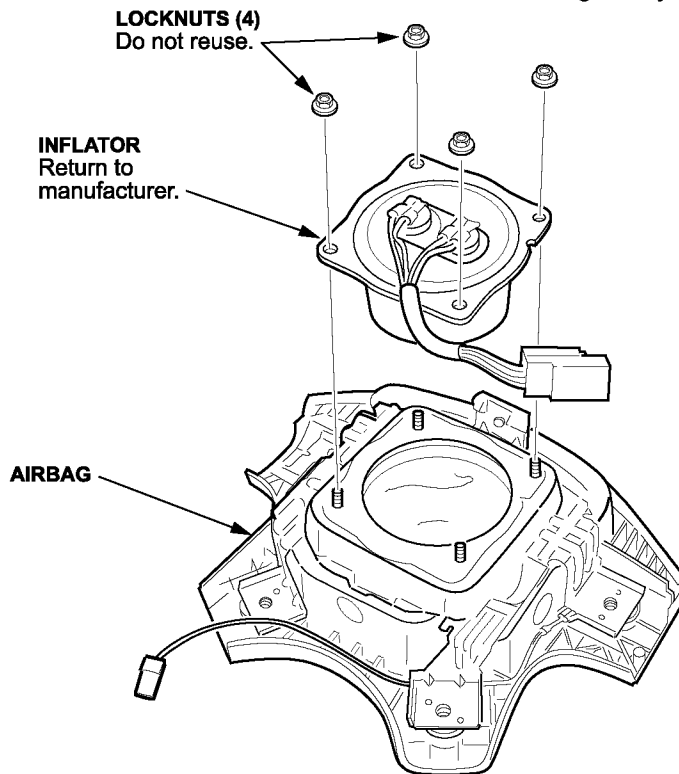
6. Remove and discard the felt tape covering the lower two inflator locknuts.
7. Using needle-nose vise grips or a 3/8 in. 6-point socket, remove the four locknuts from the inflator. The locknuts will not be reused.

NOTE: Do not remove the inflator from the airbag until you complete step 8.

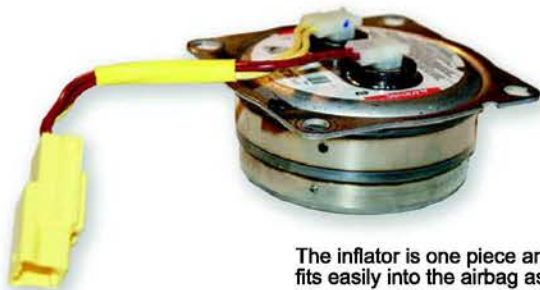
Refer to **Driver's Inflator Type 1** in the video.

The inflator is one piece and fits easily into the airbag assembly.

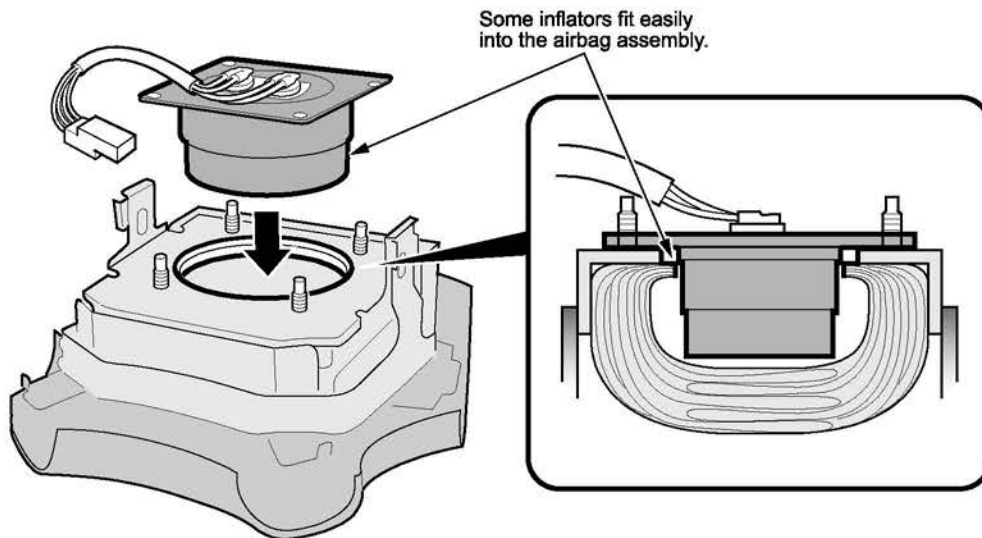
- Insert the inflator into the opening.

NOTE: Make sure the inflator wires are positioned toward the bottom of the airbag. If you install the inflator incorrectly, you may not be able to reconnect the SRS airbag harness.

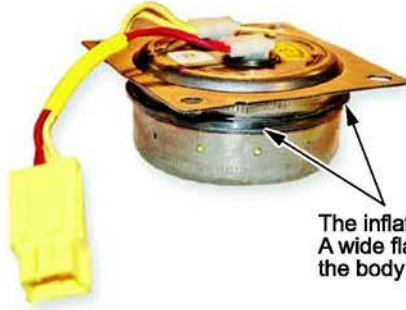
Refer to **Driver's Inflator Type 2** in the video

The inflator is one piece. A wide flange is halfway up the body of the inflator.

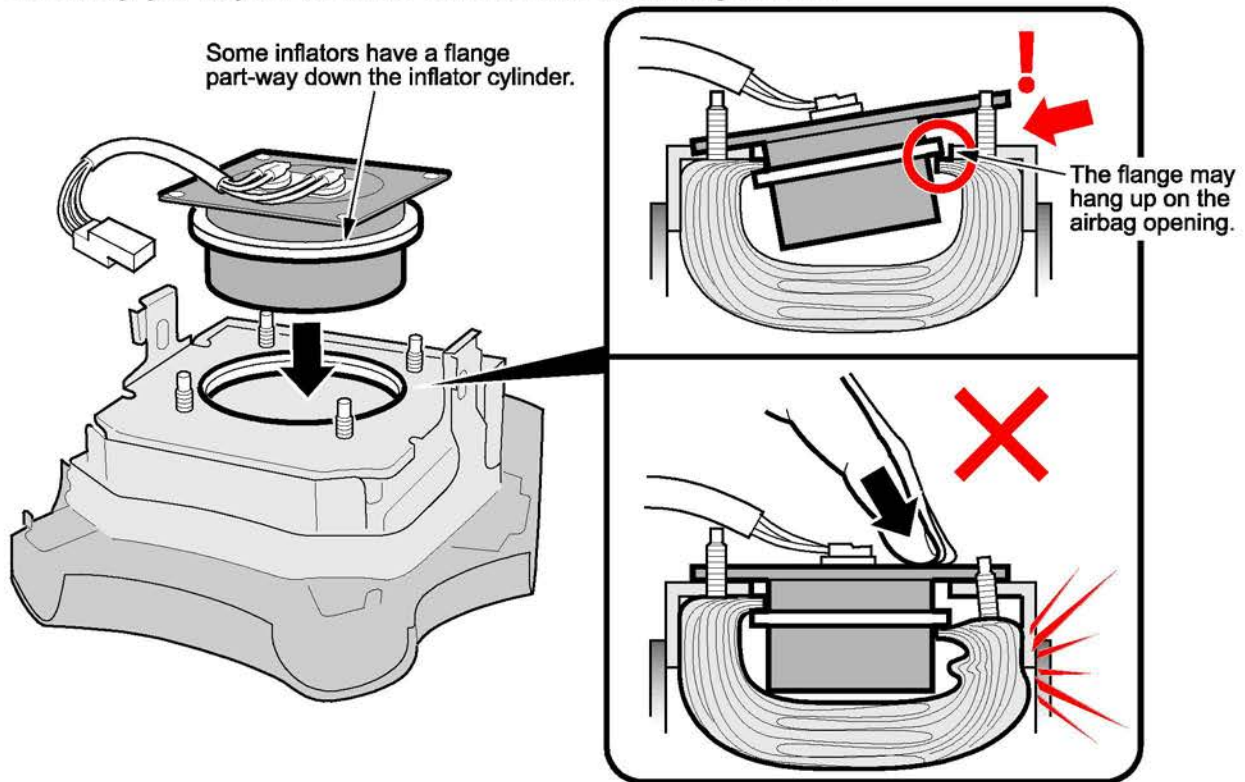
- Insert the airbag inflator into the opening. Do not force it into the airbag module.

NOTE: Make sure the inflator wires are positioned toward the bottom of the airbag. If you install the inflator incorrectly, you may not be able to reconnect the SRS airbag harness.

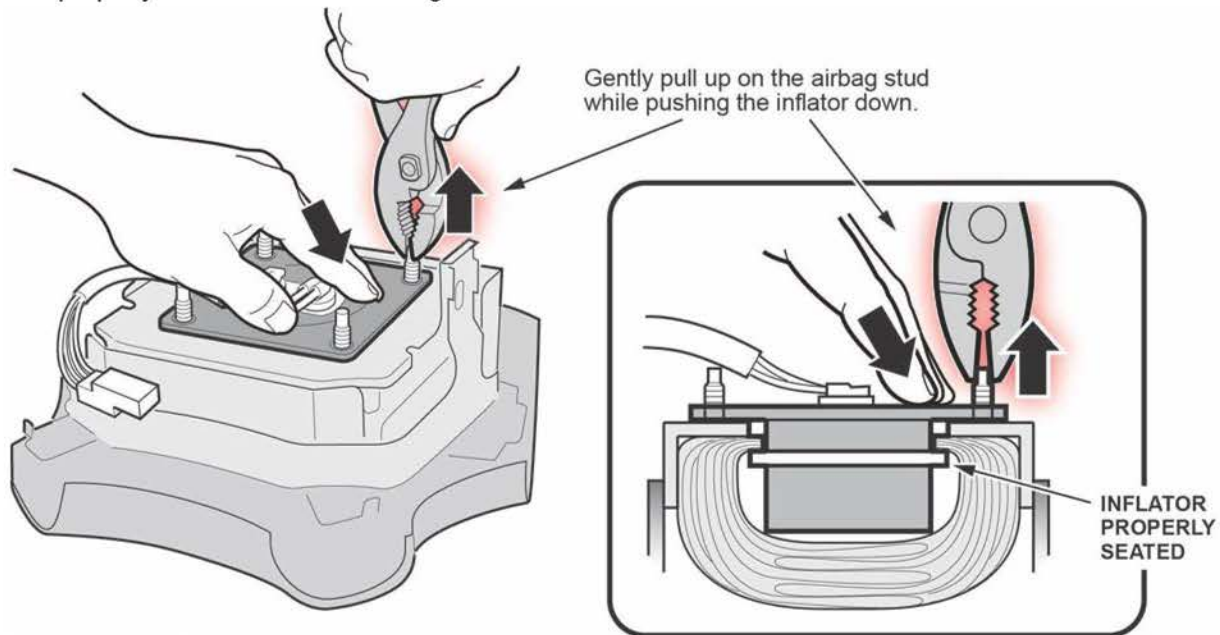
- Using a pair of pliers, gently pull up on each stud up while pushing the inflator module down until the airbag is properly seated within the airbag module.

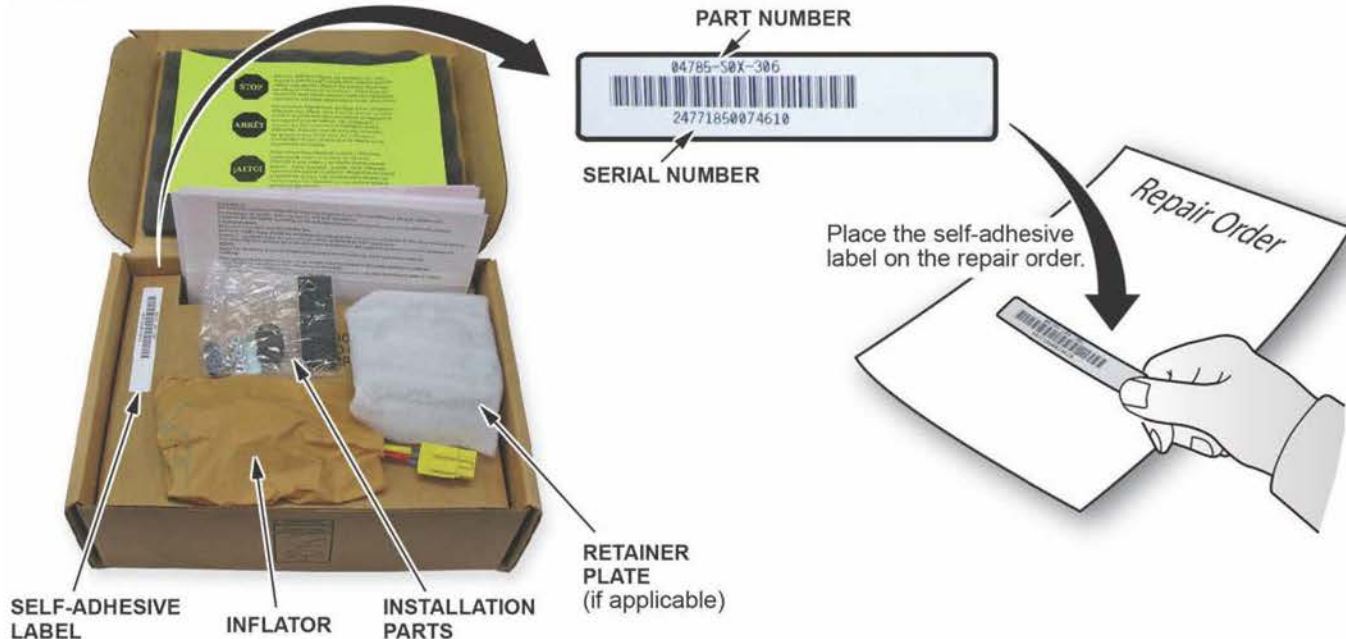
### INFLATOR PARTS BOX

- The replacement part number is printed on the top part of the label and the serial number is printed on the bottom. **Make sure you attach the label to the R.O. and give it to the warranty clerk.**
- There may also be a colored sticker located in the kit, ignore it because it is not used.
- Not all inflator kits have a label included. In those cases, write the serial number and part number from the side of the inflator box on the R.O. The part number always starts with 047.

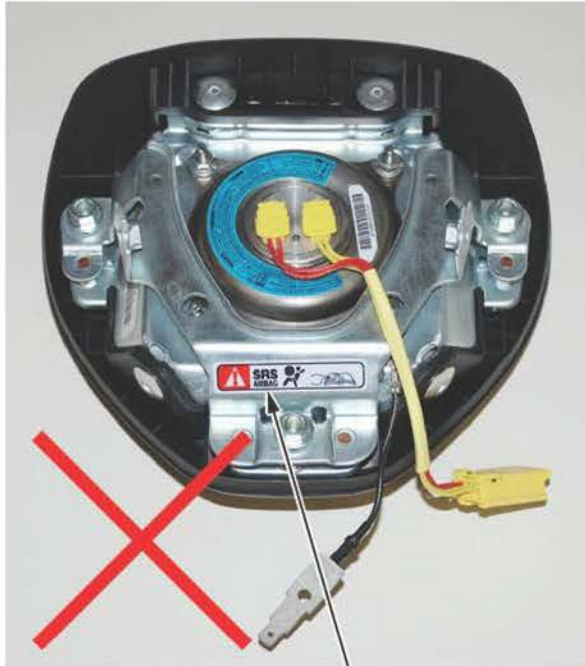
NON-STANDARD SAFETY LABEL

4. Visually inspect the airbag and the inflator for any unusual writing or markings.
  - If there is nothing unusual about the airbag or the inflator, go to step 5.
  - If there is unusual markings, like an incorrect label or a model year written in marker, the airbag and inflator may not be the correct airbag and/or inflator for the vehicle or it may be a counterfeit part. For more information about counterfeit airbags, you can refer to [safercar.gov](http://safercar.gov), enter keywords **MANAGING COUNTERFEIT**, and select Recommended Dealer Guidance for Managing Counterfeit Air Bags from the list. **If you suspect that the airbag or inflator is counterfeit, do not continue this procedure.** Contact your DPSM for assistance.

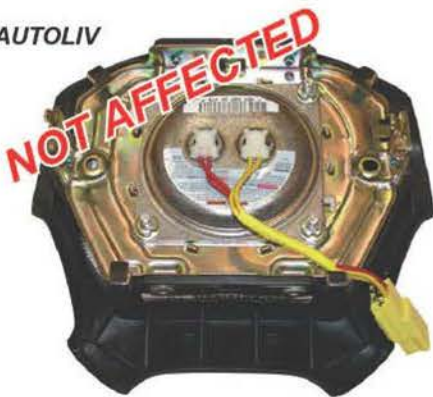
AUTOLIV

5. **Civic only** - Determine if the airbag is made by Autoliv or Takata by comparing the inflators to those in the images below.

NOTE: The Autoliv serial number label is different from the Takata label; the Autoliv has 11 characters, the Takata has 9.

- If the airbag is made by Autoliv, the airbag is OK. Reinstall the Autoliv airbag. If you already received a replacement inflator, return the unopened kit to American Honda.
- If the airbag is made by Takata, go to step 6.

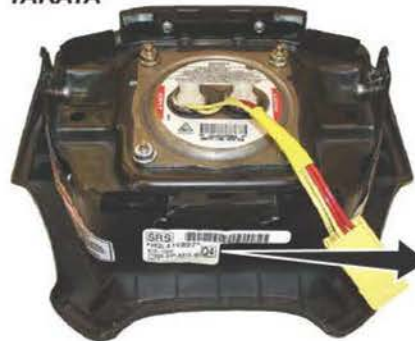
TAKATA

Locate serial number here.

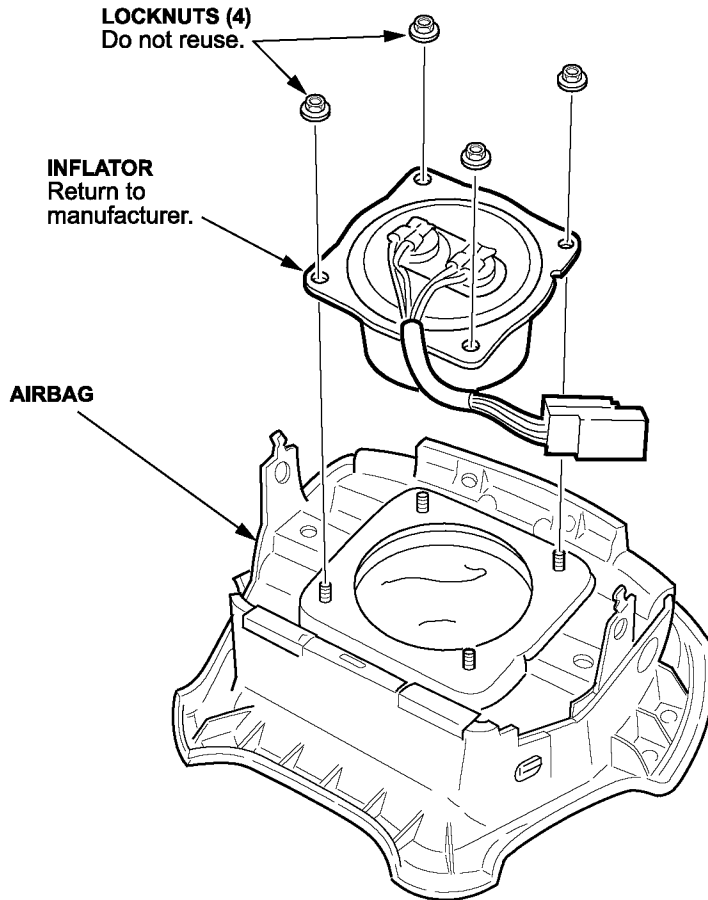
- Using needle-nose vise grips or a 3/8 in. 6-point socket, remove the four locknuts from the inflator. The locknuts will not be reused.

NOTE: Do not remove the inflator from the airbag until you complete step 7.

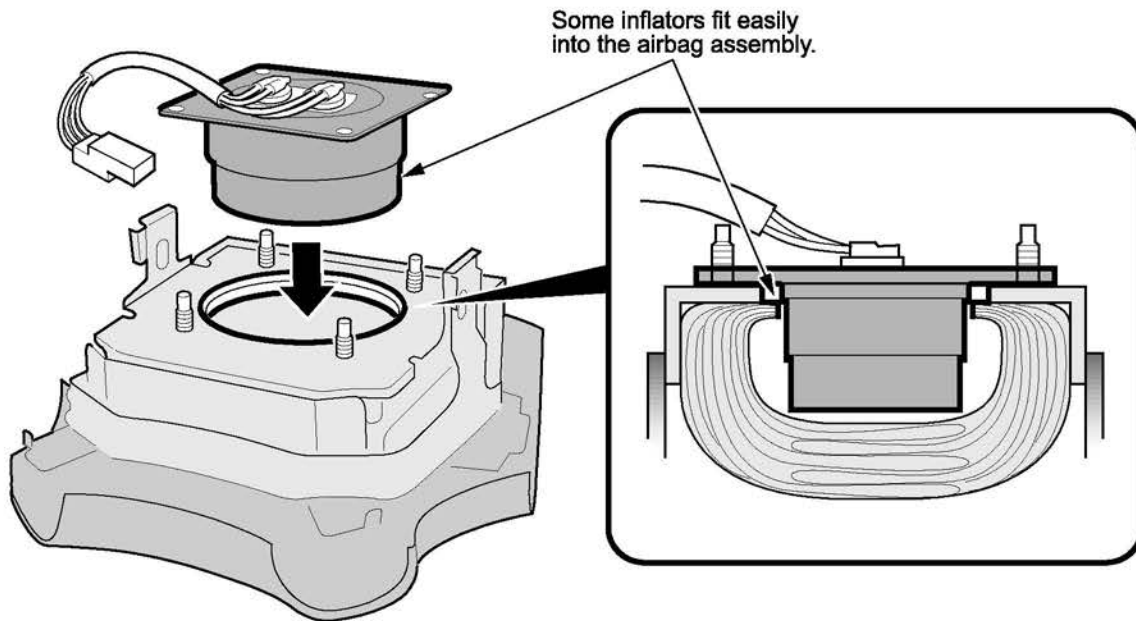
- Insert the inflator into the opening.

NOTE: Make sure the inflator wires are positioned toward the bottom of the airbag. If you install the inflator incorrectly, you may not be able to reconnect the SRS airbag harness.

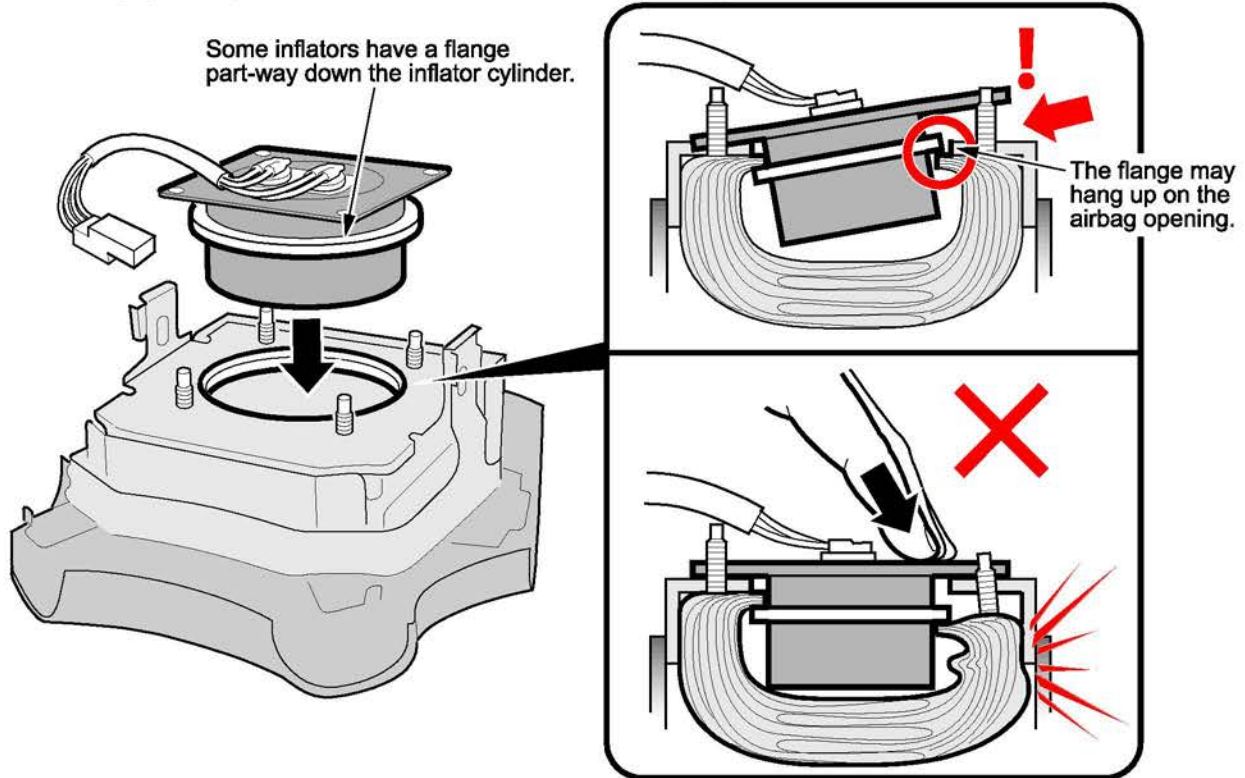
- Insert the inflator into the opening. Do not force it into the airbag module.

NOTE: Make sure the inflator wires are positioned toward the bottom of the airbag. If you install the inflator incorrectly, you may not be able to reconnect the SRS airbag harness.

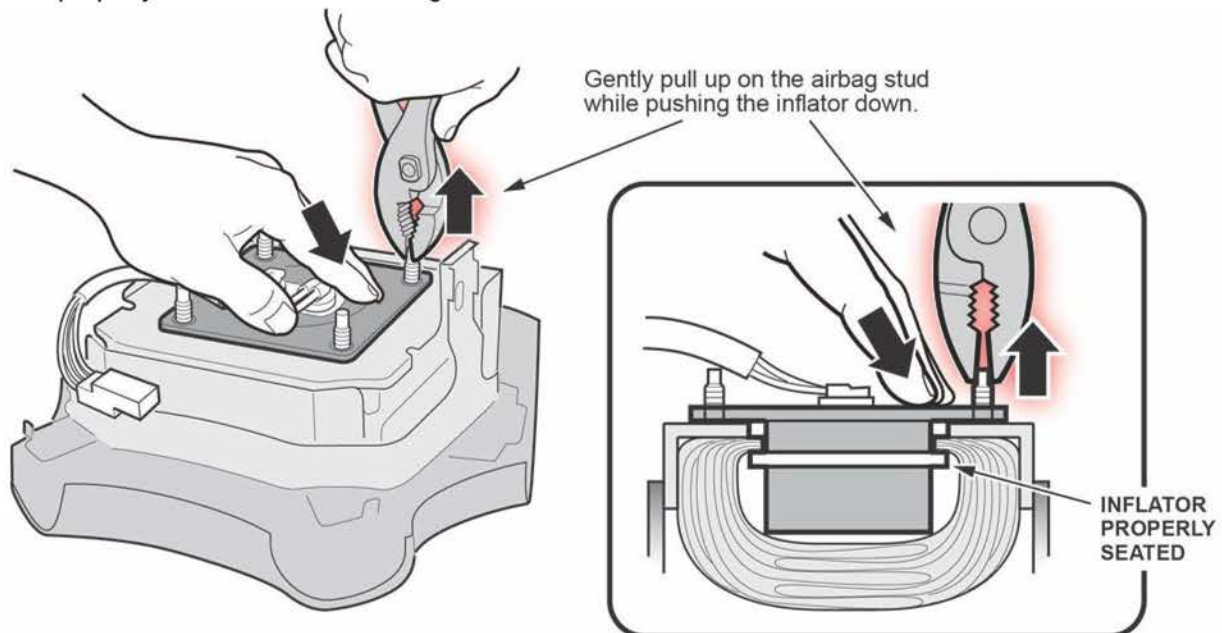
- Using a pair of pliers, gently pull up on each stud up while pushing the inflator module down until the airbag is properly seated within the airbag module.

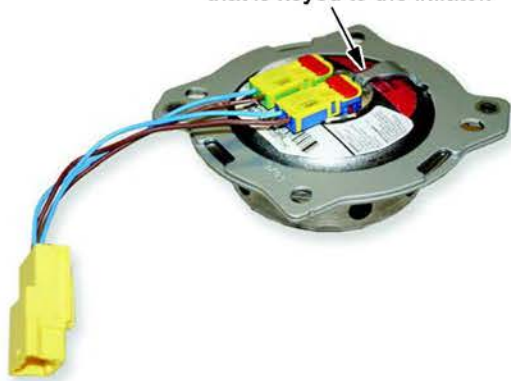
Refer to **Driver's Inflator Type 3** in the video.

The inflator is held down by a directional retainer that is keyed to the inflator.

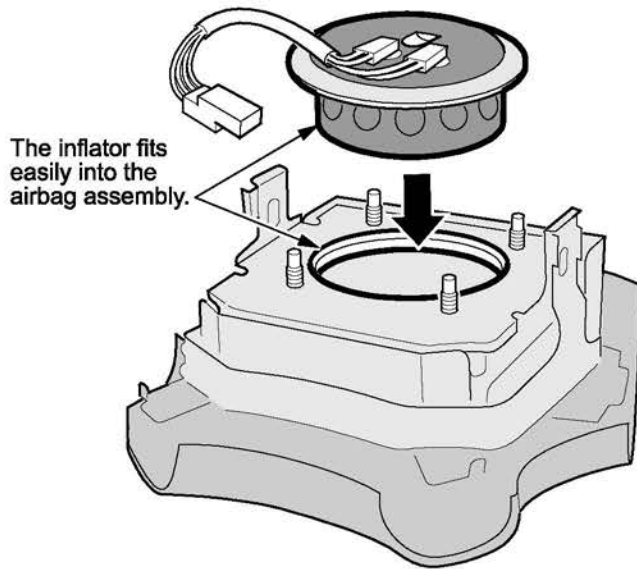
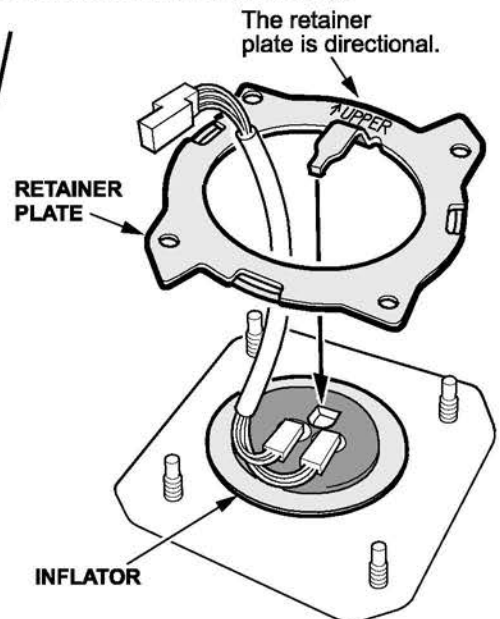
- Place the inflator into the opening with the inflator harness toward the bottom of the airbag.

- Install the bracket onto the studs. Make sure the locator tab fits into the locator hole as shown.  
NOTE: Make sure the harness comes out through the center opening. Do not install the bracket over the harness wires.

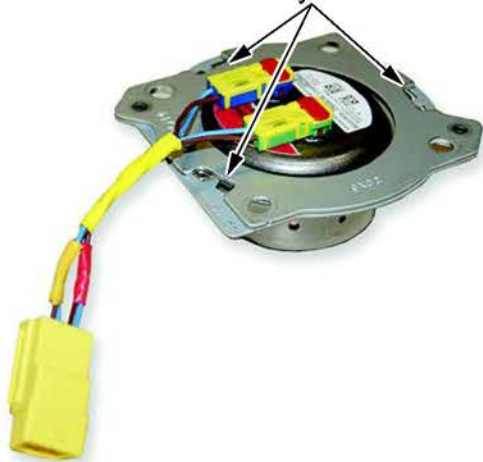
Refer to **Driver's Inflator Type 4** in the video.

The inflator is held down by a directional retainer that is keyed to the inflator.

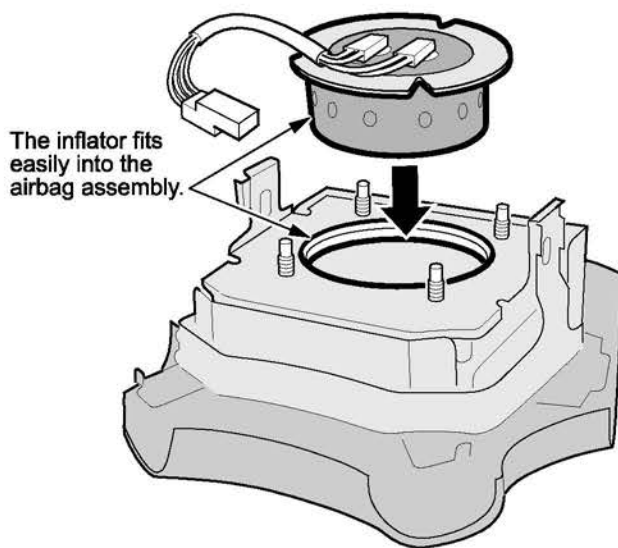
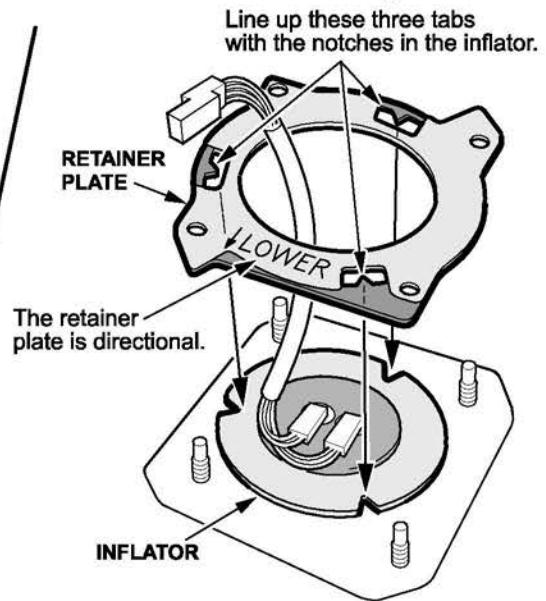
- Place the inflator into the opening with the inflator harness toward the bottom of the airbag.

- Install the bracket onto the studs with the stamp **LOWER** at the bottom of the airbag.
- Make sure the three tabs and notches are properly aligned.

- The tabs and notches are designed to align in one direction only. If the tabs and notches are not aligned, the inflator and bracket are not installed correctly.
- Make sure the harness comes out through the center opening. Do not install the bracket over the harness wires.
